## RESIDENTIAL HOME INSPECTION REPORT

2519 N 71st Dr  
Phoenix, AZ 85035

Brewer Trust  
JANUARY 31, 2024

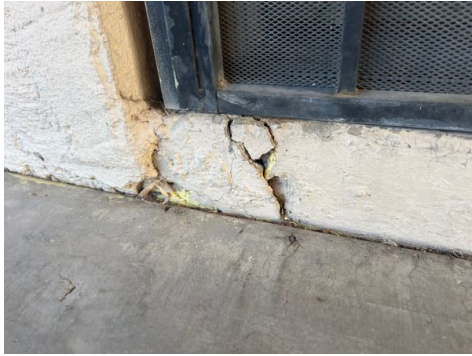
Below front door

#### CRACKED/LOOSE CONCRETE

Cracked and loose/displaced concrete was observed. I recommend the areas be reviewed and repaired by a qualified concrete/foundation repair professional to prevent moisture intrusion into the foundation.

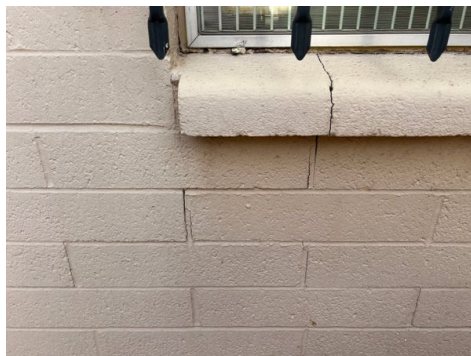
**STEP CRACKING**

Step cracking with a degree of separation between masonry units was observed. I recommend consulting a licensed professional to review/repair.

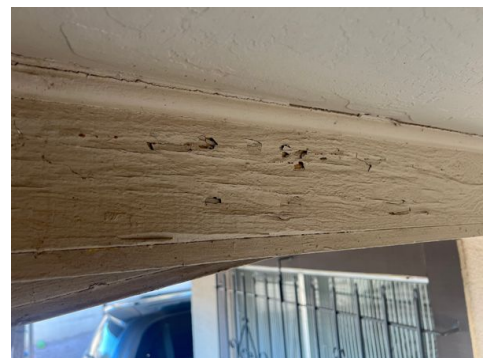
**WDI DAMAGE**

Wood destroying insect damage was observed at the front patio cover beam, near the front entry door. I recommend consulting a licensed contractor to review/repair.

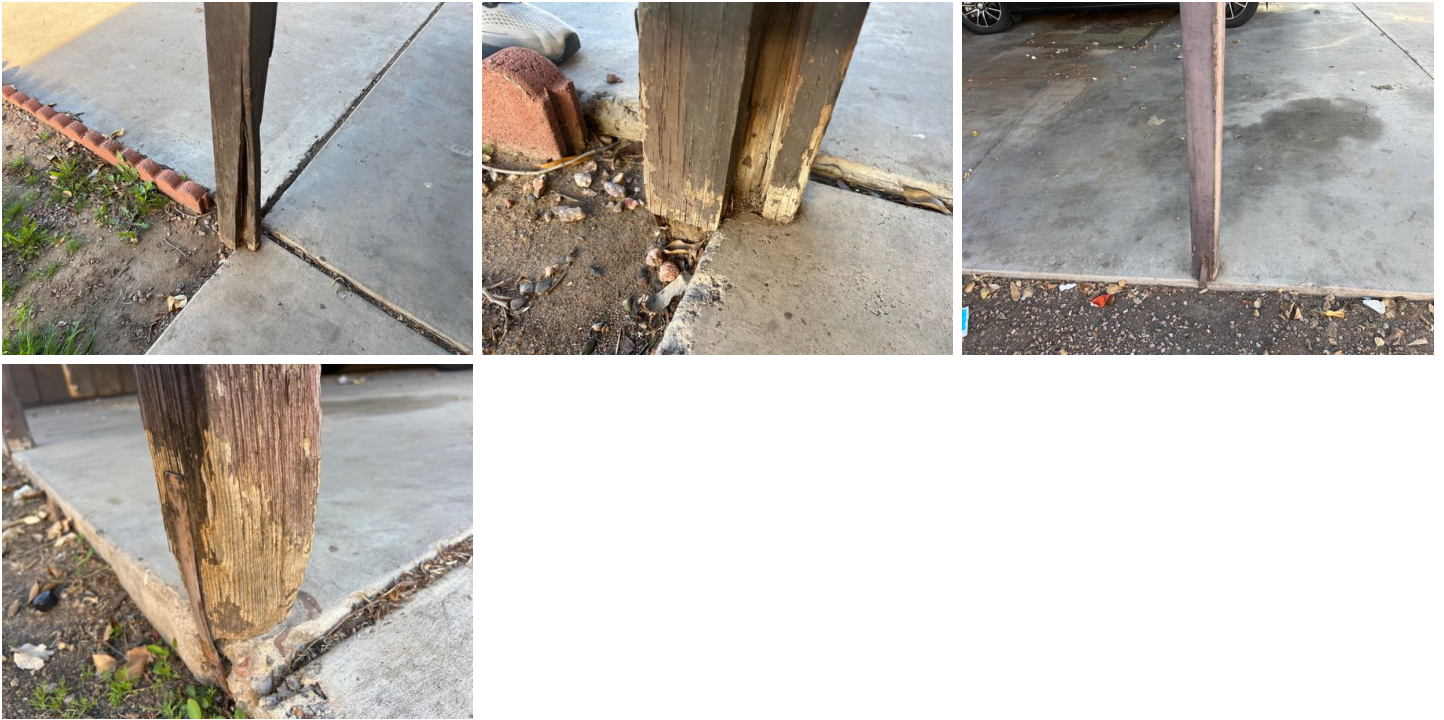
2.5.2 Columns & Beams

One of the carport posts is cracked/damaged and hanging off of the concrete slab below. Another post is noticeably twisted. The third post is damaged/missing material at the bottom. I recommend consulting a licensed professional for repair.

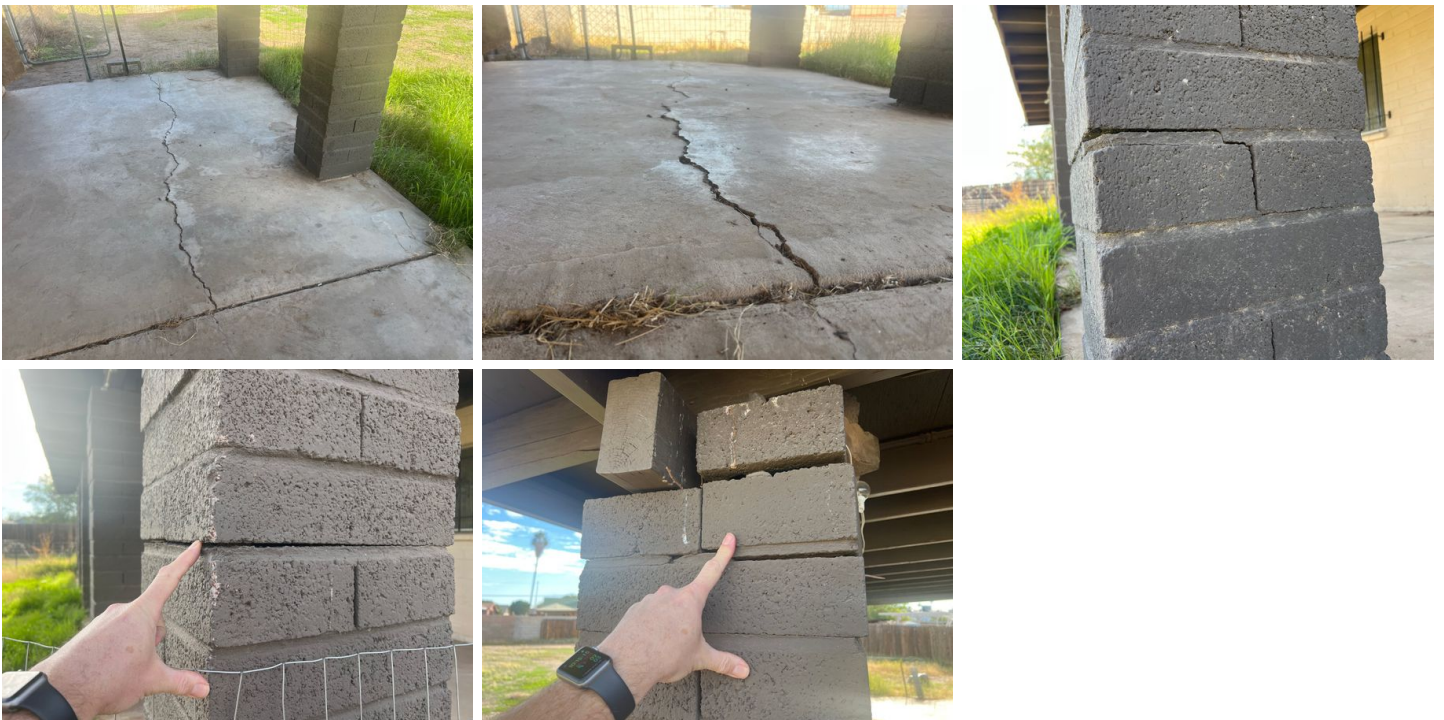
2.5.3 Columns & Beams

The rear patio slab has cracked, settled and heaved to a degree. Two masonry columns appear as though they could be resting on this concrete. I was not able to determine if a separate footing is installed. A degree of movement was observed at the masonry columns. I recommend consulting a licensed contractor to review/service.

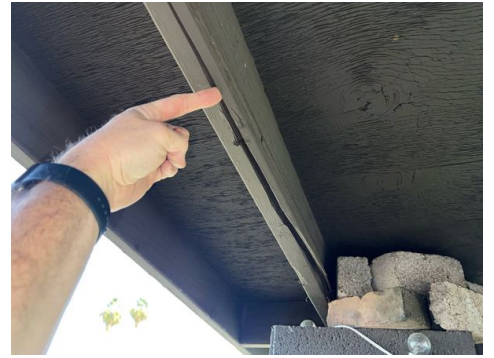
## 2.6.1 Roof Structure

One of the rear patio cover wood rafters is cracked/damaged. I recommend consulting a licensed plumber to review and repair as deemed necessary.

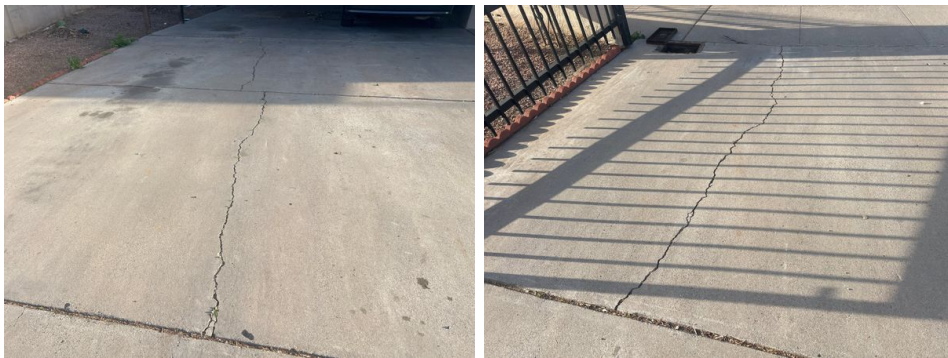
Cracked and chipped concrete was observed at the driveway. The condition could worsen with water penetration. A concrete repair professional can be consulted for service/to seal as needed.

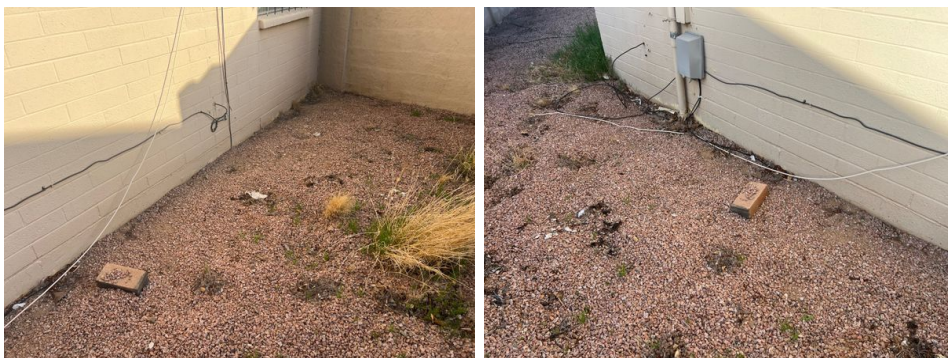
### 3.2.1 Vegetation, Grading, Drainage & Retaining Walls

Exterior grade is flat and/or negatively sloped in some areas. A slope of approximately **1 inch per foot away** from the foundation is recommended for at least the first few feet so that proper drainage can be maintained. I recommend grading conditions be corrected where necessary by a qualified grading or landscape professional.

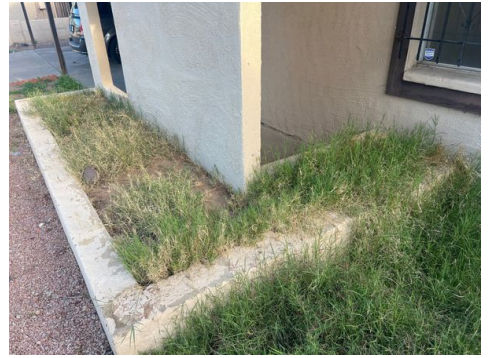
### 3.2.2 Vegetation, Grading, Drainage & Retaining Walls

A planter is installed at the front of the home. Soil is held against the exterior wall in the area. Visibility of the wall is limited. This can cause moisture to be held against the wall which can lead to damage/deterioration. I recommend removing the planter.

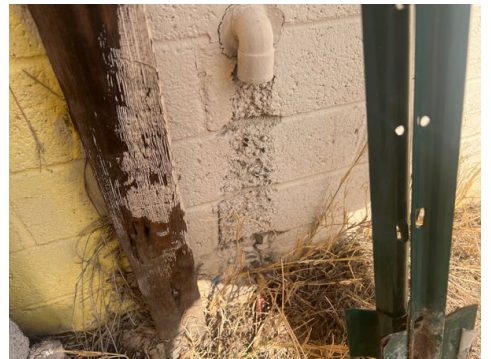
3.2.3 Vegetation, Grading, Drainage & Retaining Walls

Masonry and concrete below the cooling system condensate drain is eroded. This is likely an older condition as this drain pipe is no longer being used. A qualified professional should be consulted for repair to the exterior wall as needed.

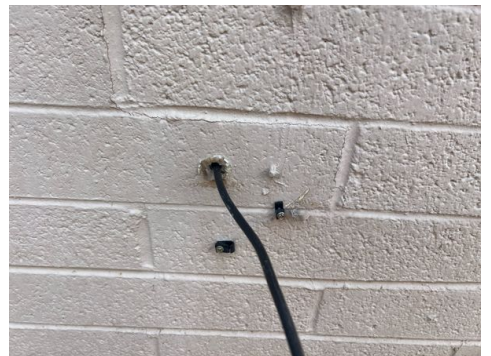
3.3.1 Cladding/Siding, Flashing & Trim

Exterior wall penetration(s) are not sufficiently sealed in some areas. Openings/penetrations should be sealed with approved exterior caulk/sealant to prevent pest and moisture intrusion.

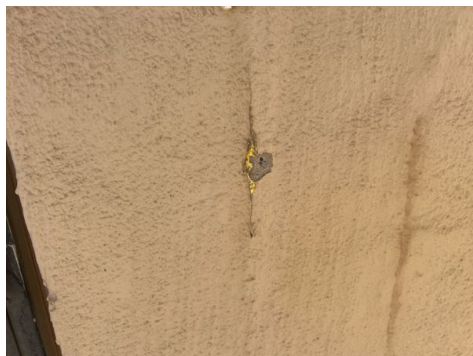
**STUCCO CHIPS**

Chipped stucco was observed in some areas. I recommend patching and painting where needed.

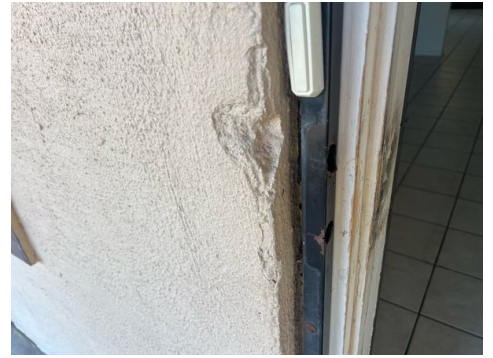
3.3.3 Cladding/Siding, Flashing & Trim

Chipped/damaged exterior masonry was observed next to the front entry door. I recommend consulting a qualified professional for repair as needed.

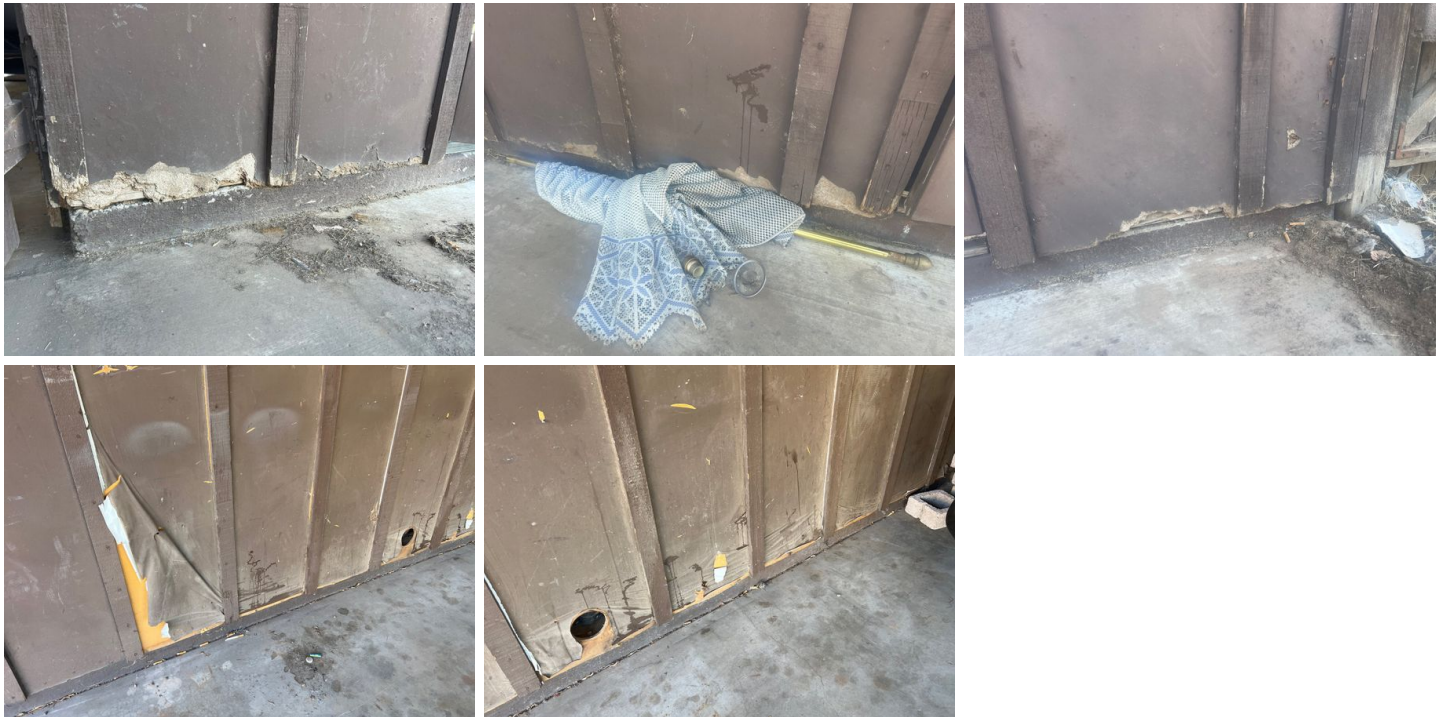
3.3.4 Cladding/Siding, Flashing & Trim

Panel siding at the exterior laundry/storage area is weathered/damaged in areas and finish is peeling in areas. I recommend consulting a licensed professional to replace damaged materials.

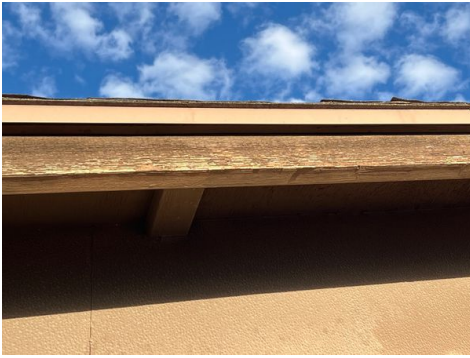
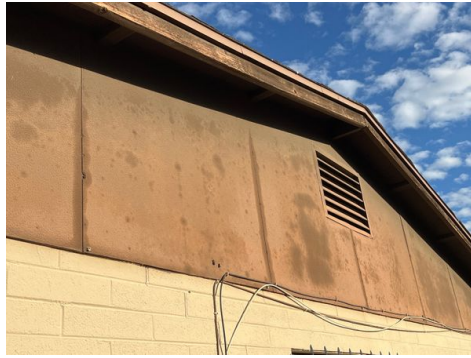
**FLAKING/WEATHERED EXTERIOR PAINT**

Exterior paint is flaking/cracking and appears to be generally weathered in some areas. Loose paint should typically be scraped and exposed areas repainted. An exterior painter can be consulted for service if needed.

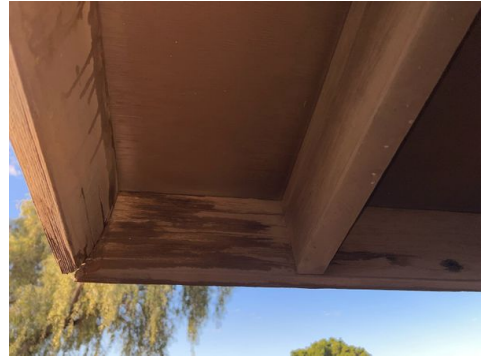
**WATER STAINS**

Water stains were observed at some roof eaves/overhang locations. The conditions could be due to wind driven rain or potentially a degree of roof leaking. Observed conditions that can contribute to leaking have been documented in the roof section. Stains can typically be resealed and repainted. I recommend monitoring for indications of worsened stains that can indicate roof leaks.

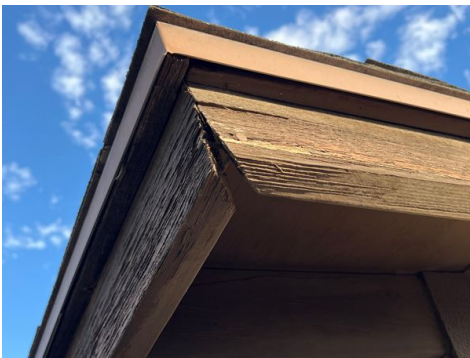
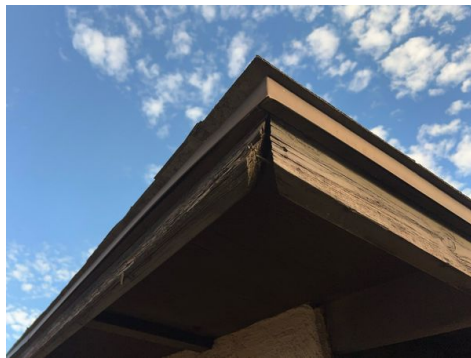
**SEPARATED FASCIA**

Roof eave fascia is separated in some areas. I recommend adding or replacing fascia nails plates as needed.

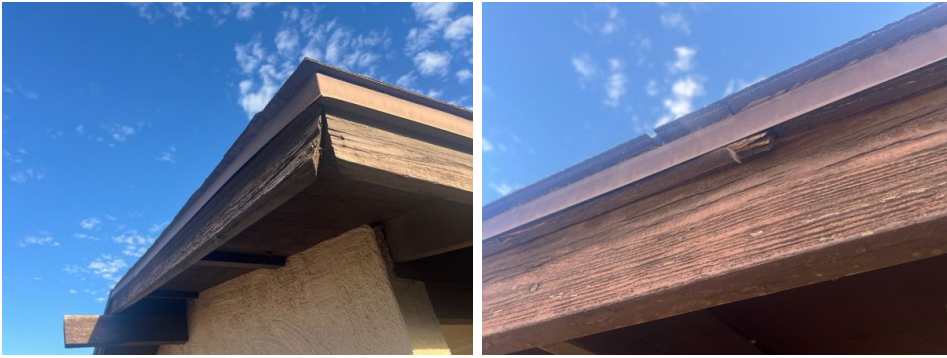
Weathered and/or curling and splintered roof eave fascia was observed in some areas. Weathered and loose trim was also observed. A qualified/licensed professional can be consulted to replace as needed.

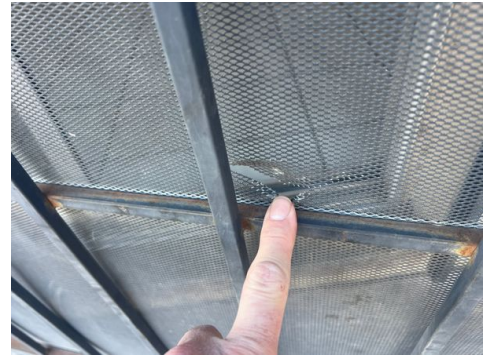
## 3.6.4 Exterior Entry Doors

The kitchen security door screen is damaged/cut in one area. The door is serviceable otherwise.

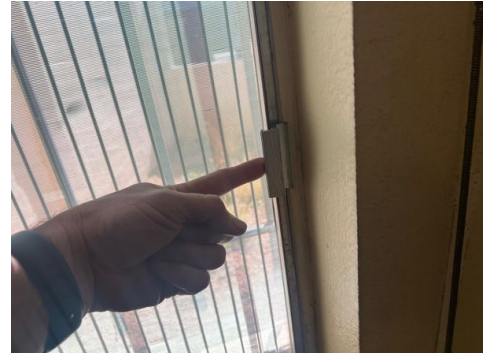
GUEST BEDROOM

Some of the windows were difficult to lock after opening. A window repair professional can be consulted for adjustment.

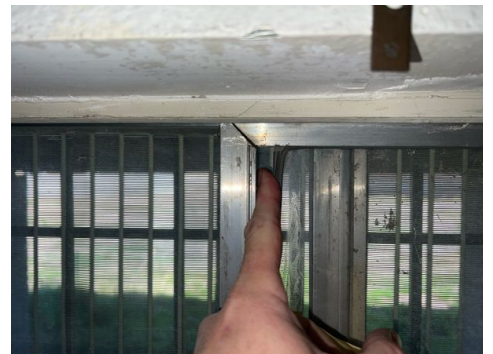
The sash is loose and separated from window glazing/glass. I recommend consulting a qualified window repair professional for service.

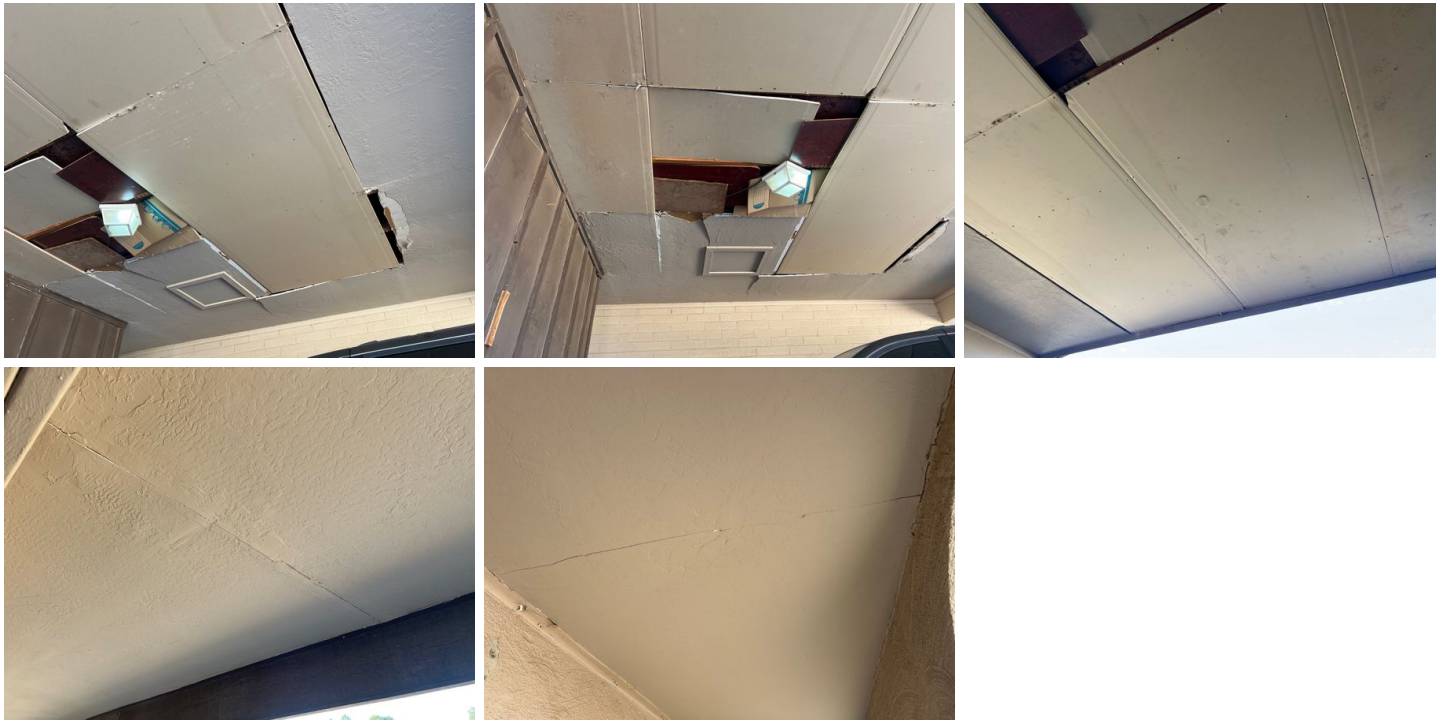
Drywall is damaged, missing, and unfinished at the carport ceiling. Cracked drywall was also observed near the front entry door. I recommend consulting a licensed drywall installer for service.

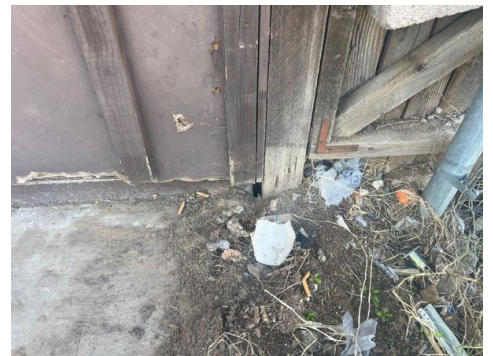
3.9.1 Fence

Wood is contacting grade and is secured to/contacting the exterior wall. This is a condition that can be conducive to wood destroying organism activity and damage. A non-wood barrier should be installed between the wood fence and siding. A qualified/licensed professional can be consulted for service.

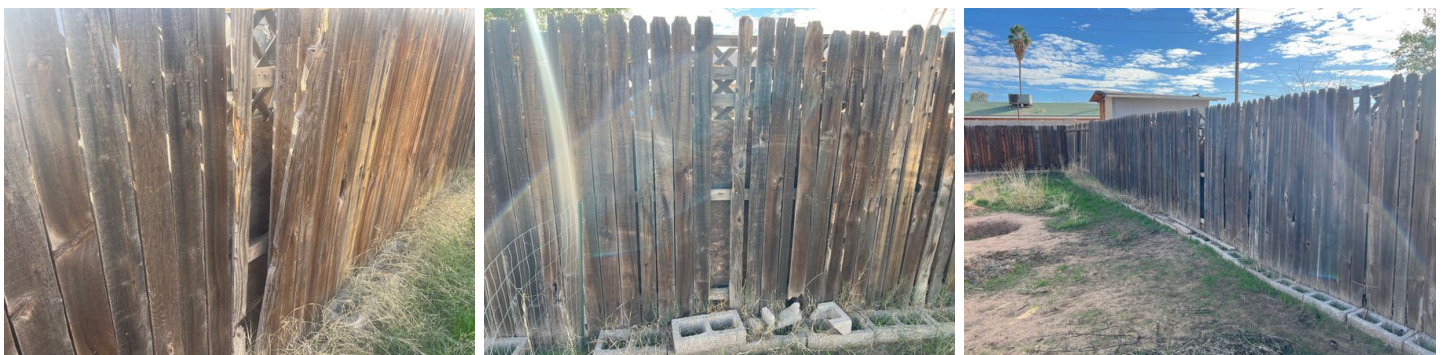
3.9.2 Fence

Perimeter fence wood planks are damaged and/or missing in some areas. Wood destroying insect damage was observed as well. I recommend service/replacement as needed by a qualified fence installer.

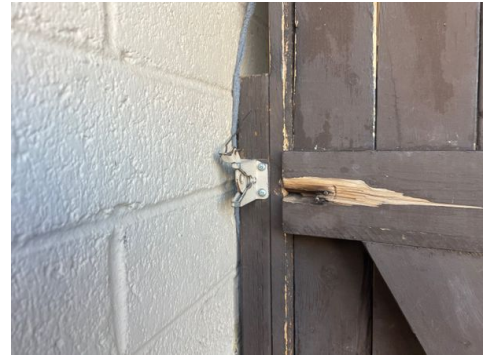
3.10.1 Gates

The latch arm for the gate is missing. The post secured to the wall is loose as well.

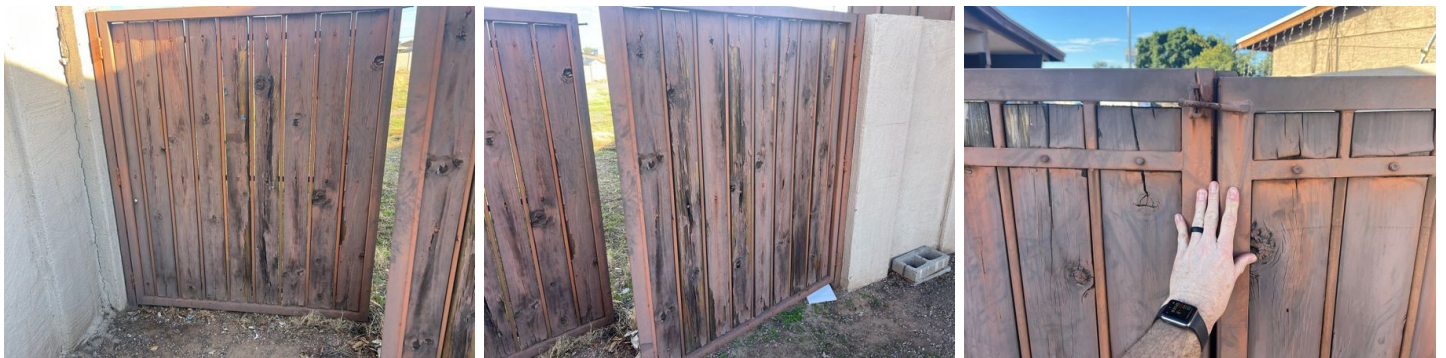
3.10.2 Gates

The RV gate is difficult to fully close and latch. It seems as though the doors are too close to each other. Some of the wood planks are cracked and split and paint is generally weathered.

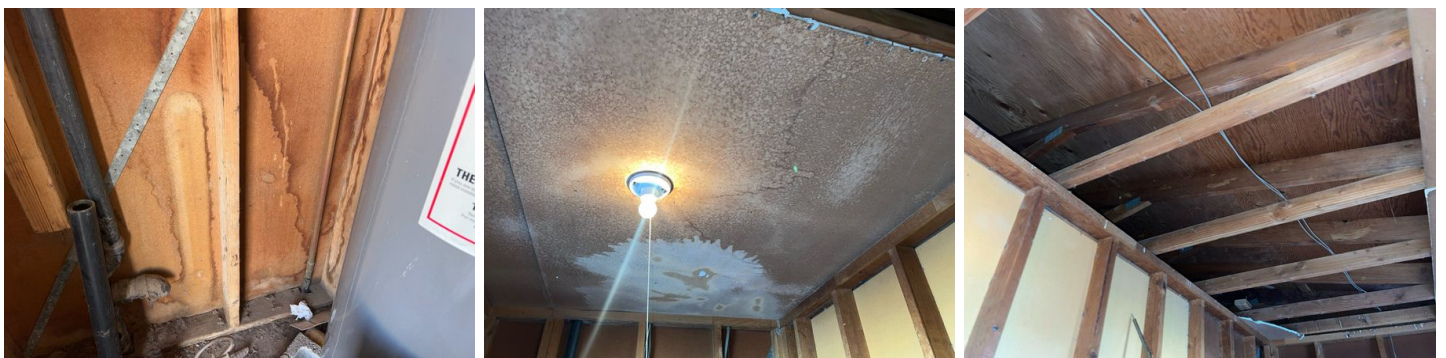
3.11.1 Laundry/Utility Room

Water stains were observed within the exterior laundry area at siding and drywall. Drywall is also missing at the majority of the ceiling. I recommend consulting a licensed professional for repair.

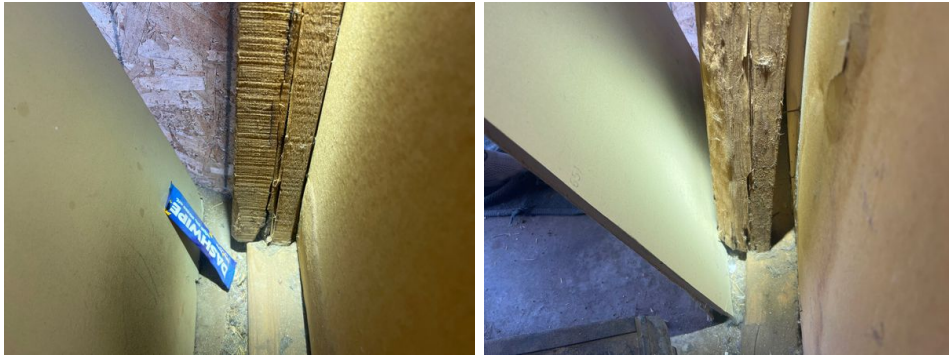
3.11.2 Laundry/Utility Room

Wall framing between the carport and laundry area is cracked/damaged and offset from the sill plate in some areas. I recommend consulting a licensed professional for repair.

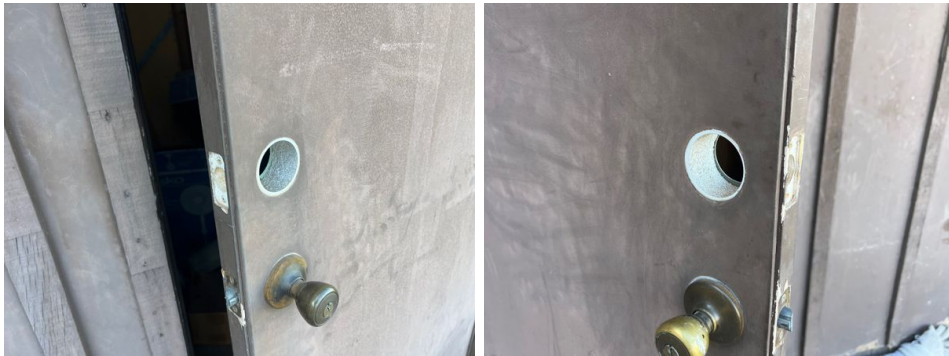
3.11.3 Laundry/Utility Room

Deadbolt hardware is missing from the exterior laundry/storage area entry doors.

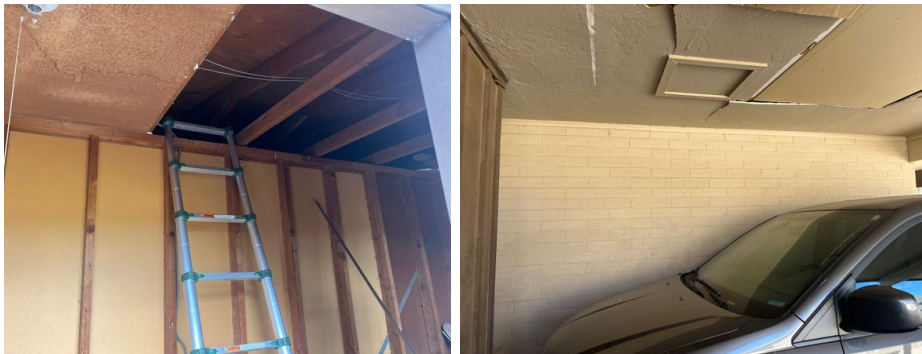
The attic was inspected from a ladder in the exterior laundry area. I was not able to inspect the attic from the carport access due to a van below. Please note that visibility was limited, and I was not able to get a good look at insulation and the majority of the framing. Follow up inspection service is available if the van is able to be removed.

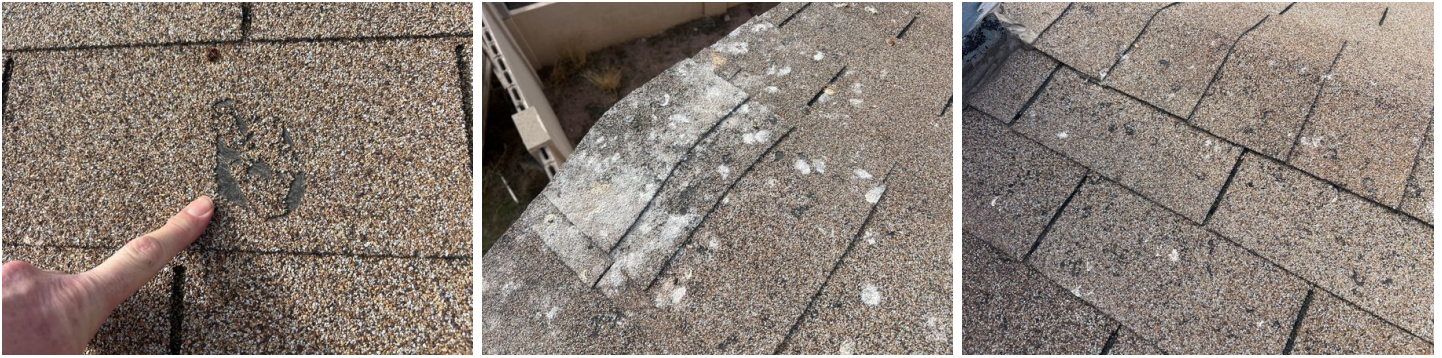
Physical damage/granule loss was observed at some of the asphalt shingles. I recommend consulting a qualified roof repair professional to review/service.

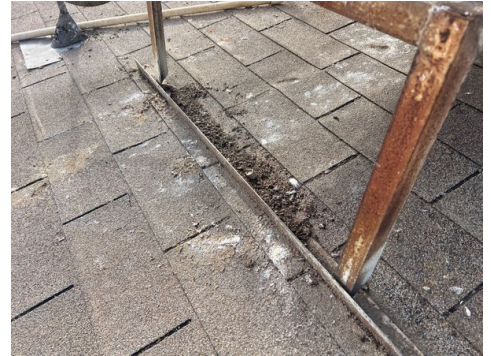
4.1.2 Roof Coverings

Pigeon droppings were observed on the roof. Excessive accumulation of pigeon droppings and debris can lead to deterioration of roof covering materials and/or limited drainage and leaking. I recommend all pigeon debris be removed and a means of deterrent installed by a qualified pest control technician.

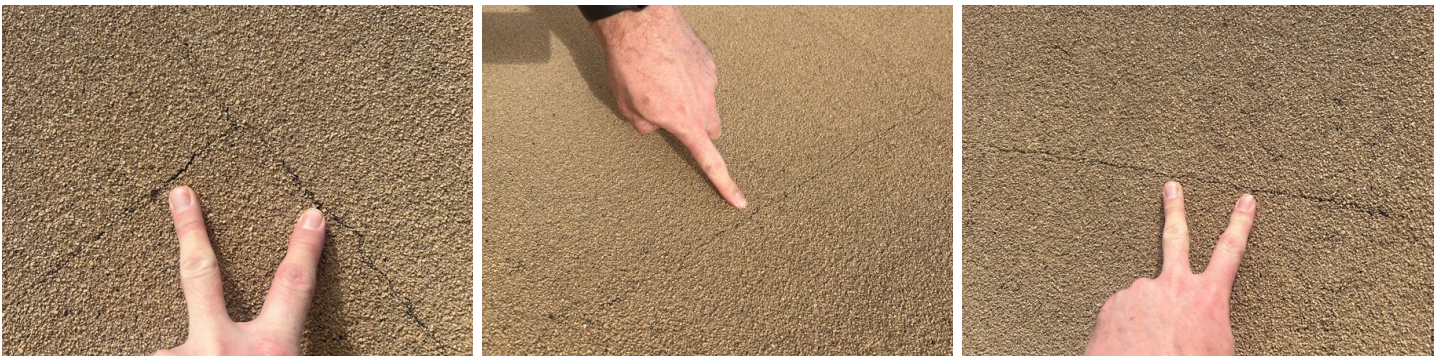
4.1.3 Roof Coverings

A degree of minor cracking was observed at the patio roll roof covering. No major damage was observed, however, the condition could worsen. I recommend consulting a qualified roof repair professional to review and seal as/when needed.

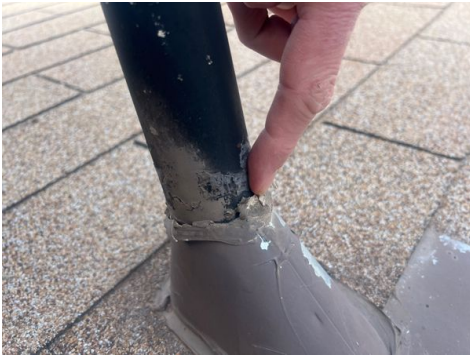
**CRACKED/OPEN COLLARS**

Flashing collars are open/not fully sealed in some areas. This can lead to leaking into the attic. I recommend consulting qualified roof repair professional for service.

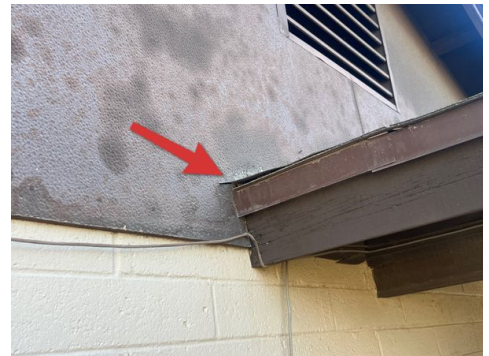
**MISSING KICK-OUT FLASHING**

Kick-out flashing is missing at the intersection of the roof covering and sidewalls in some areas. Kick-out flashing helps prevent moisture intrusion into the wall cavity and/or will help prevent exterior siding damage. I recommend adding kick-out flashing. A qualified roofer can be consulted for service.

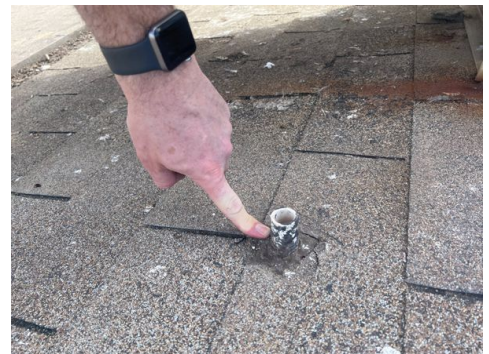
**MISSING FLASHING**

At least one roof penetration is not flashed. The penetration(s) are sealed only with roof cement. Roof cement is not considered to be a permanent water barrier. Permanent flashing should be installed where possible. I recommend consulting a qualified roofer to assess/install flashing if/where possible.

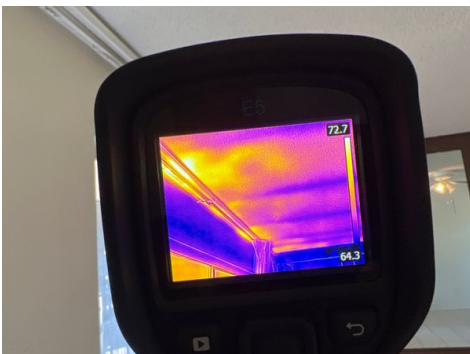
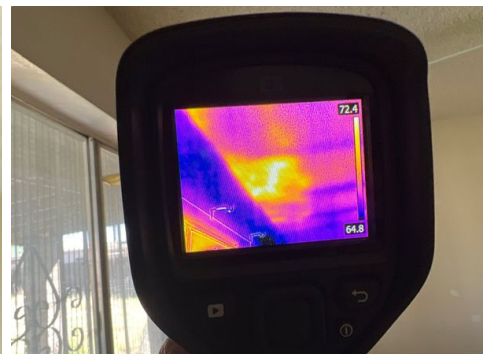
**APPARANT LOW, MISSING OR DISPLACED INSULATION**

Attic insulation appears to be low, displaced, or missing as observed utilizing an infrared camera. I recommend consulting an insulation installer to add insulation where necessary.

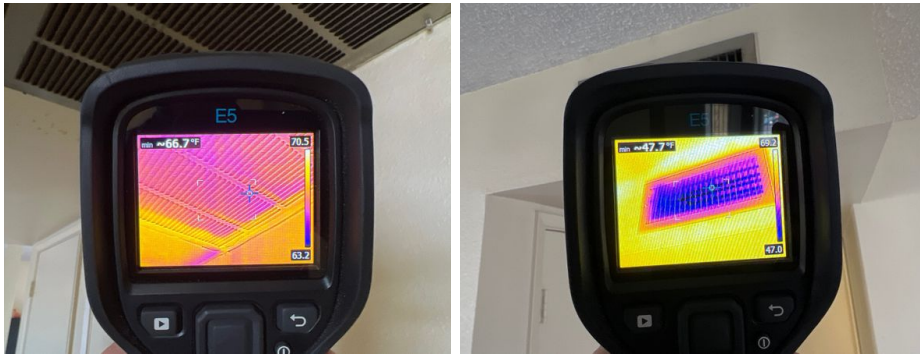
The difference in temperature between the cooling system return and registers was approximately 19 degrees. Please note this was measured using an infrared thermometer/camera. The actual air temperature could vary. Additional factors that can influence the temperature differential are not measured by these tools.

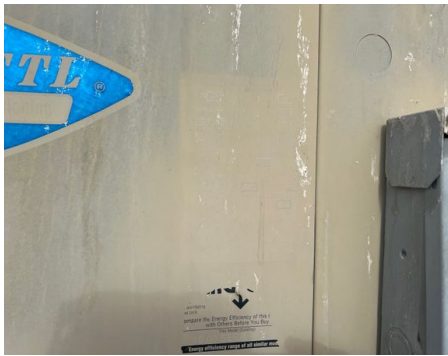
### Central Cooling System(s): Label missing or not legible

The data label for the air conditioner is missing or no longer legible. I am not able to determine the age of the unit or type of refrigerant the unit is compatible with. A qualified HVAC professional should be consulted to further assess and provide these specifications.

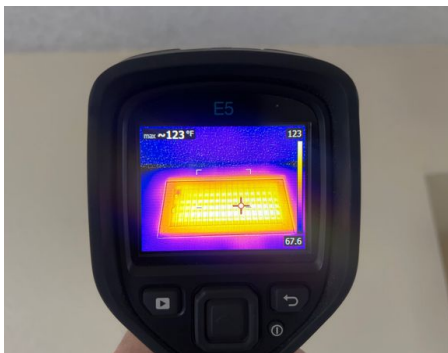
### Heating System(s): Functional heat pump

The heat pump system was tested in heat mode and warmed air to an acceptable temperature.

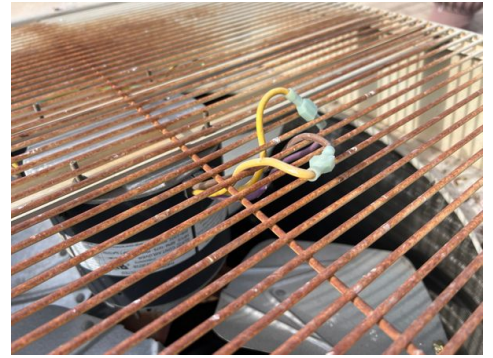
Electrical conductors are partially exposed for the cooling system condenser fan. This is a fairly common condition that typically indicates the fan has been replaced. Electrical conductors that are continuously exposed to UV will break down (insulation will become brittle). I recommend consulting a licensed HVAC professional for service.

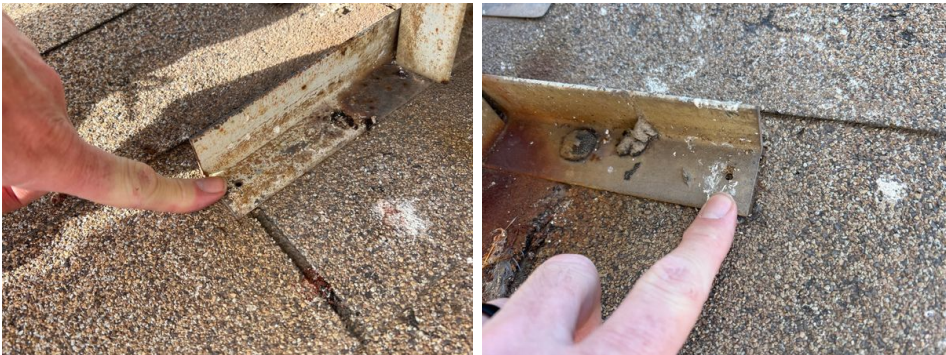
### 5.1.2 Central Cooling System(s)

2 of 4 fasteners to secure the roof mounted heating and cooling unit bracket to the roof are missing. I recommend consulting a qualified professional to add and replace hardware as necessary.

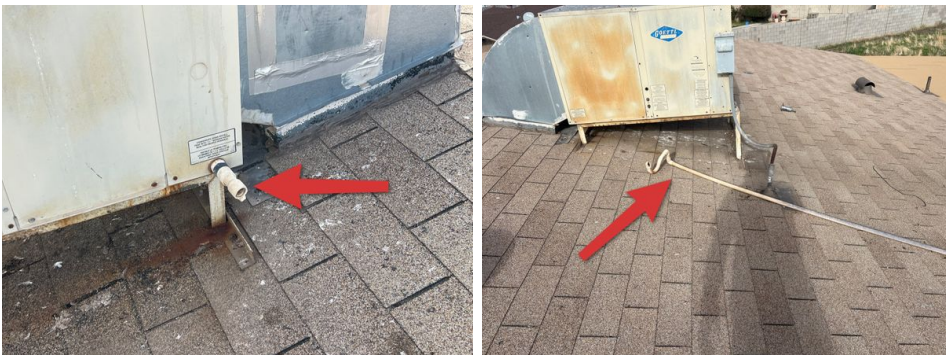
### 5.1.3 Central Cooling System(s)

The cooling system condensate drain is detached. This will cause water to drain down along the roof covering. The roof covering could become damaged or eroded along the drainage path. I recommend consulting a qualified HVAC repair professional for service.

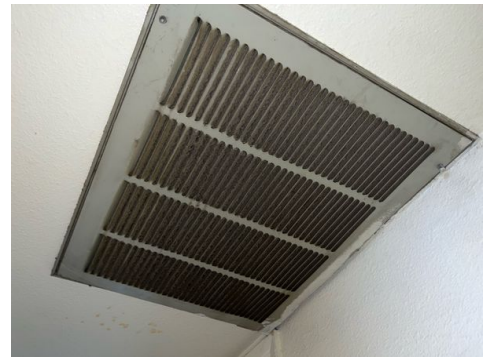
5.4.1 Distribution System

The air filter(s) are dark/dirty and should be replaced so proper air flow may be established and to prevent dirt/dust accumulation within the system.

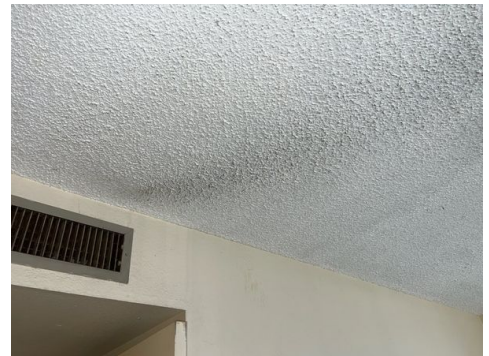
**DUST AROUND/NEAR REGISTERS**

Interior walls appear dusty/dirty around HVAC registers. This could indicate a need to have the distribution system cleaned. A qualified duct cleaning professional could be consulted for service.

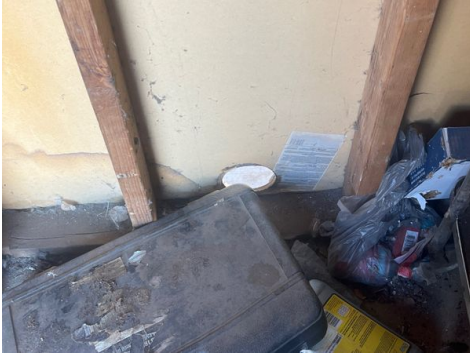
**NO DRYER VENT**

There is no vent installed. There is only a opening in siding. I recommend consulting a qualified professional to install a vent and exterior hood/damper.

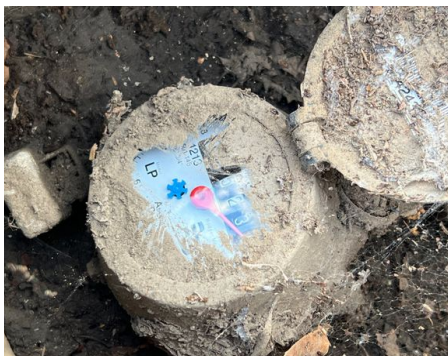
**Water Supply & Distribution System: No Indication of Water Flow at Meter**

The utility water meter was observed with all fixtures off. The meter did not indicate water was flowing to the home.

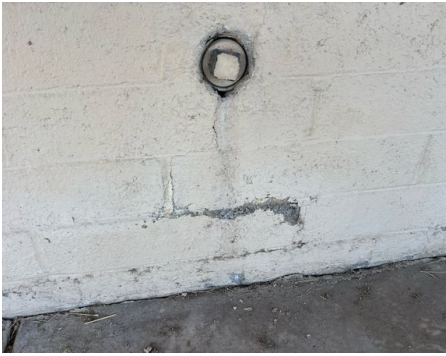
### Drain, Waste, & Vent System : Evidence of leaking

Evidence of leaking was observed below a rear cleanout. No active leaking was observed, however, masonry is moisture damaged to a degree.

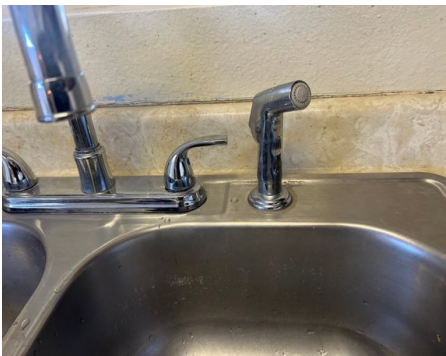
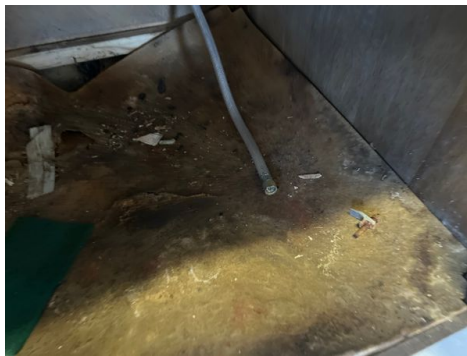
### Sinks & Faucets : Side spray not connected

The kitchen sink side spray was not connected at the time of the inspection.

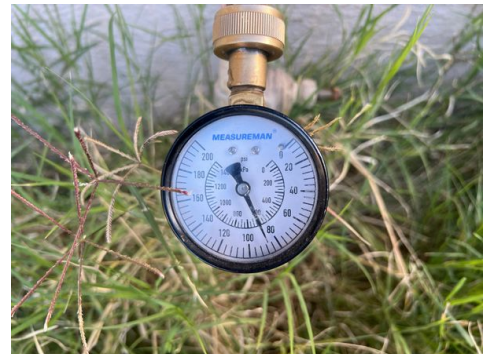
#### HIGH WATER PRESSURE

Utility water pressure exceeded 80 PSI at the time of the inspection. A maximum of 80 PSI is commonly recommended to limit stress on the interior water supply system and fixtures/fittings. I recommend consulting a licensed plumber to install a pressure reducing valve.

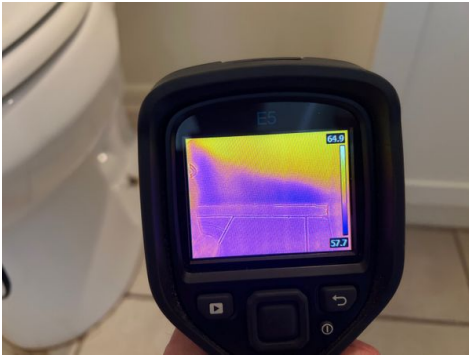
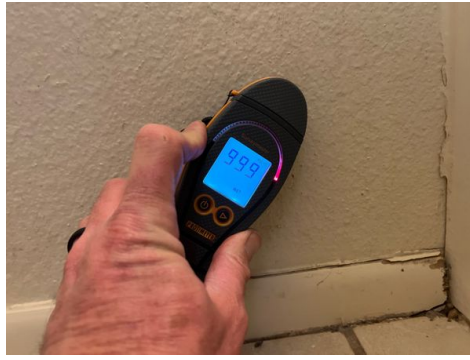
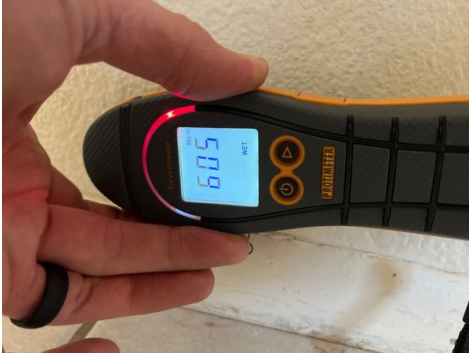
#### POSSIBLE LEAK IN/NEAR WALL

Elevated moisture was indicated behind the primary bathroom toilet, all the way from the shower to the cabinet. Elevated moisture was also indicated on the opposite side of the wall, in the living room. This could be a result of the shower leaking or could suggest another leak that is not visible. I recommend consulting a licensed contractor/plumber to further review.

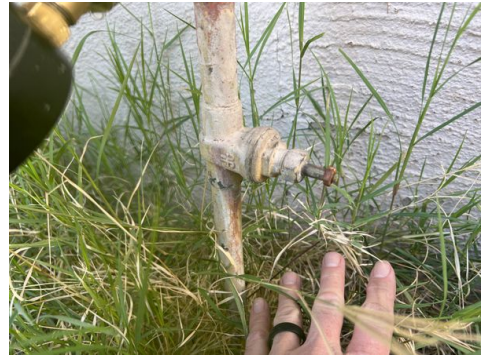
The handle for the main water shut off valve is missing/has been removed. This is an older gate style valve, known to be prone to corrosion/damage. I recommend consulting a licensed plumber to replace the handle or the valve.

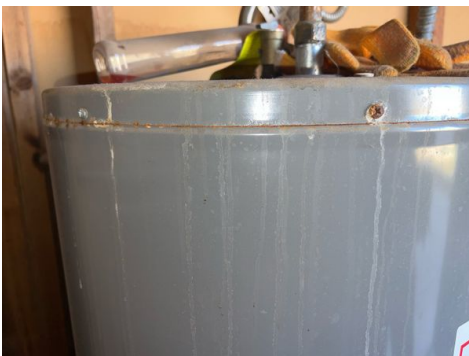
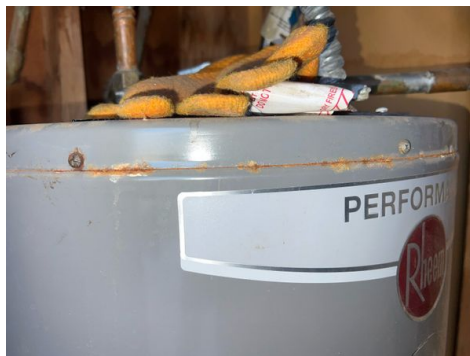
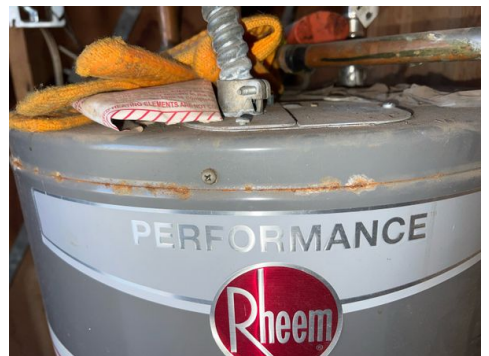
**WATER HEATER RUST/DRIP MARKS**

Rust/corrosion and drip marks were observed running down the water heater. It appears as though the unit has leaked. I recommend consulting a licensed plumber to review and replace if necessary.

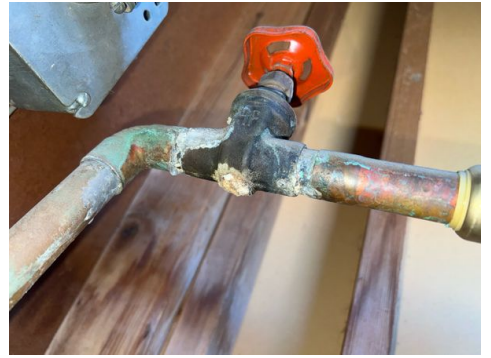
Corrosion was observed at the water heater supply valve. Corrosion can lead to water restriction and/or leaking. No active leaking/dripping was observed. A licensed plumber should be consulted to replace.

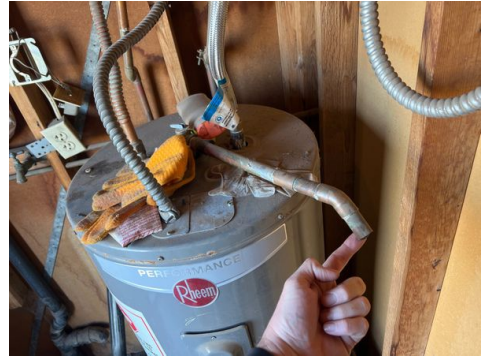
## 6.4.3 Hot Water Systems

The majority of the water heater temperature and pressure relief valve discharge pipe is missing. This is a safety concern. A pipe is needed direct hot pressurized water to a safe location. I recommend consulting a licensed plumber to install a discharge/drain pipe.

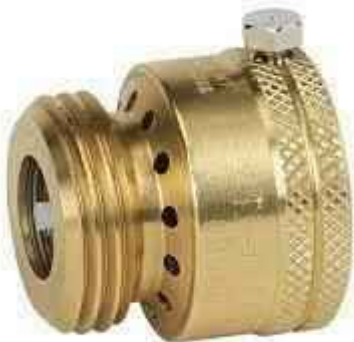
**MISSING HOSE BIB VACUUM BREAKERS**

A connected hose without a vacuum breaker may draw contaminated water into the clean/potable water supply. I recommend installing vacuum breakers where missing/before connecting hoses.

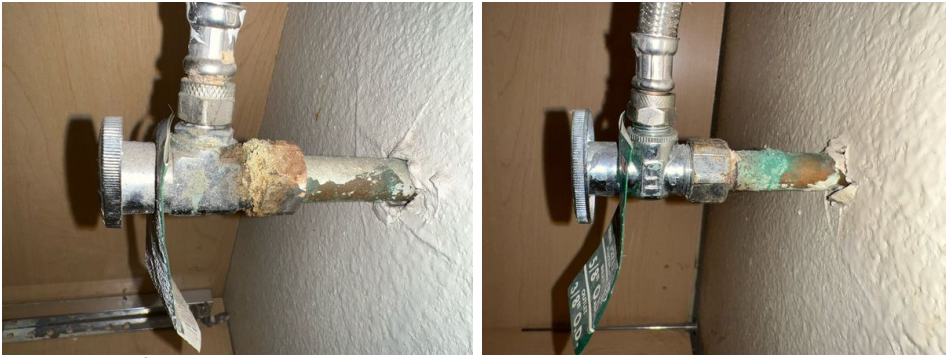
Calcification and/or corrosion was observed at sink supply/shut-off valves. While no active leaking or dripping was observed at the valves the condition could indicate securing/tightening or replacement is necessary.

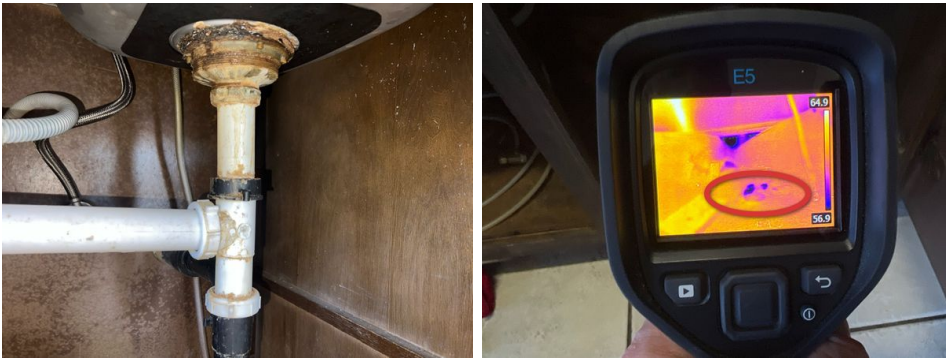
Primary Bathroom

Active sink drain leaking was observed when the sink was tested. I recommend repairs be performed by a qualified plumber in a timely manner as to not cause (additional) damage to cabinetry and nearby finish material.

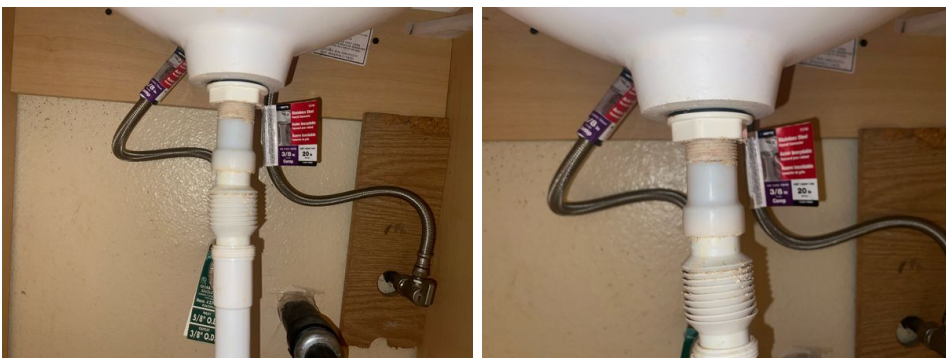
6.8.3 Sinks & Faucets

Flexible drain pipe material is installed. This type of flexible pipe it typically not recommended/allowed as it does not have a smooth interior and can be prone to clogging. Indication of leaking was observed. I recommend consulting a licensed plumber for service.

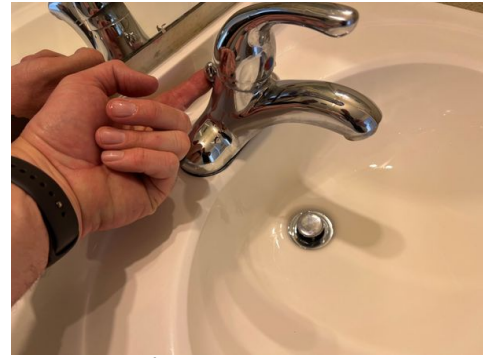
## 6.8.4 Sinks &amp; Faucets

The sink drain stop is inoperable and/or does not function as intended. A plumber can be consulted for service or replacement.

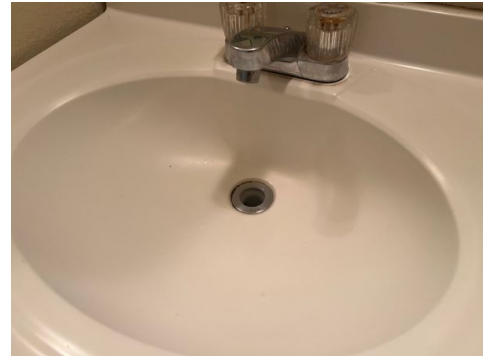
Primary Bathroom

Missing drain stop(s) observed. Drain stops should be replaced as foreign objects may easily fall into the drain(s). A qualified professional/plumber can be consulted for service.
