## RESIDENTIAL HOME INSPECTION REPORT

2519 N 71st Dr  
Phoenix, AZ 85035

Brewer Trust  
JANUARY 31, 2024

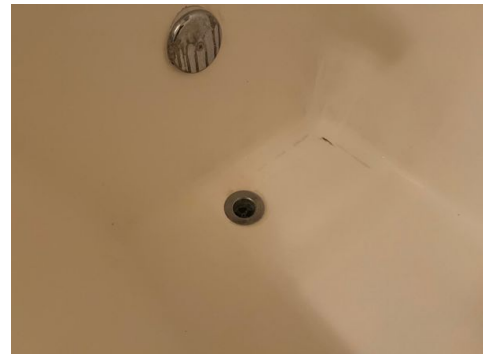
**MISSING DRAIN STOP**

GUEST BATHROOM

The openable portion of the built-in drain stop is missing. A rubber stop could be used or a plumber could be consulted to replace the built-in stop.

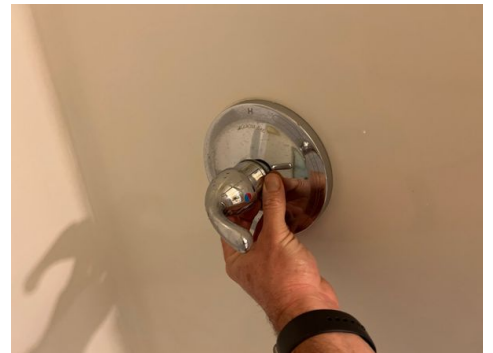
**LOOSE PLUMBING**

Plumbing supply pipe/components for the tub/shower are loose in the wall. Distribution material should be strapped and secured to prevent unnecessary movements that could result in loosening of fittings and leaking/dripping. A licensed plumber can be consulted to determine the feasibility of securing this plumbing.

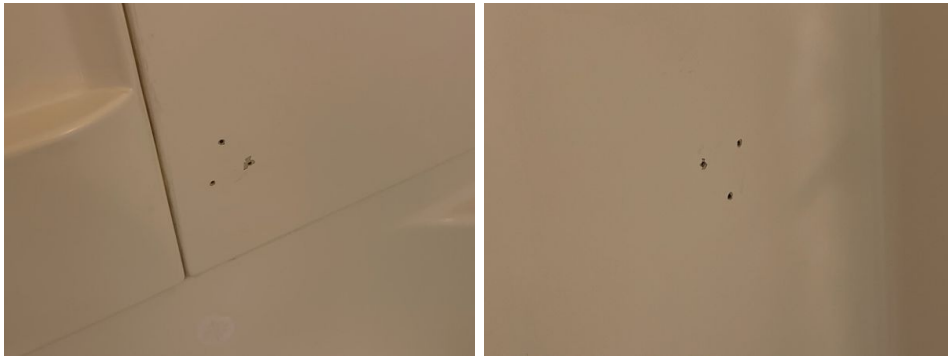
Open hardware holes at the primary bathroom shower should be patched/sealed to prevent moisture intrusion.

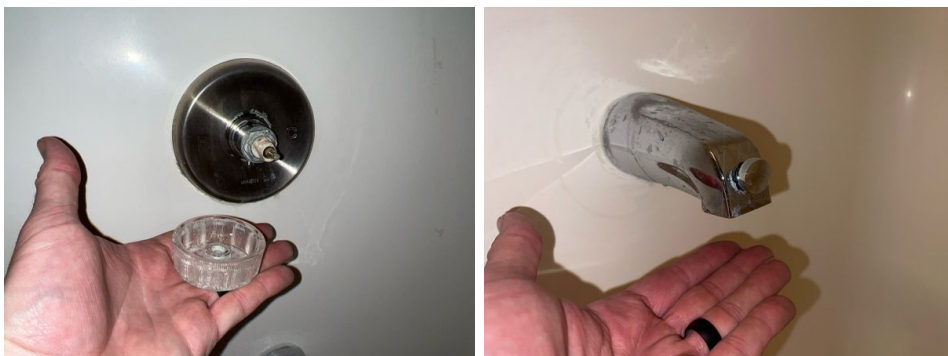
6.9.4 Bathtubs & Showers

The tub/shower control valve in the guest bathroom drips from the handle. The knob is not secure. The tub spout also drips with the handle fully off. I recommend consulting a licensed plumber for repair.

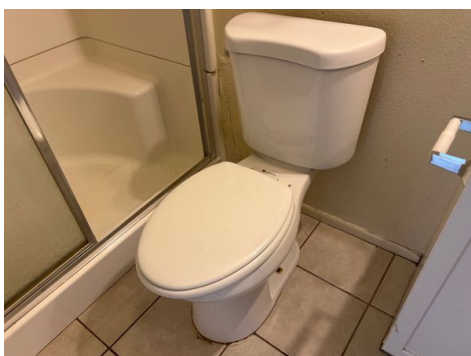
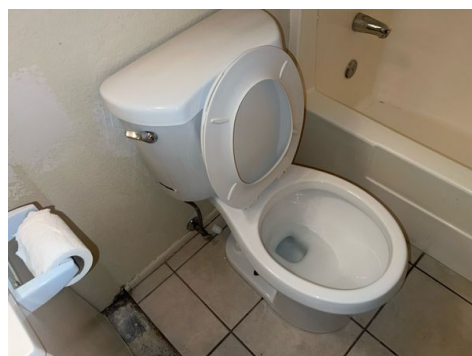
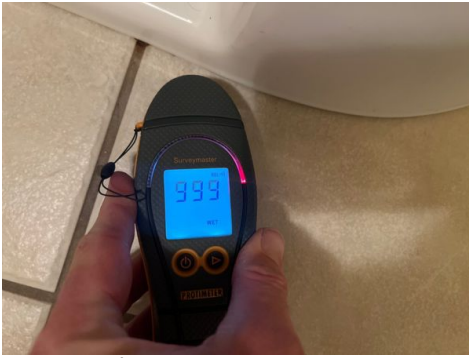
**LOOSE TOILETS**

The toilets are not properly secured to the floor. The tanks are loose as well. Elevated moisture was indicated below tile nearby. There was no water available at the primary bathroom toilet. I did not attempt to turn the valve on. I recommend consulting a licensed plumber for repair.

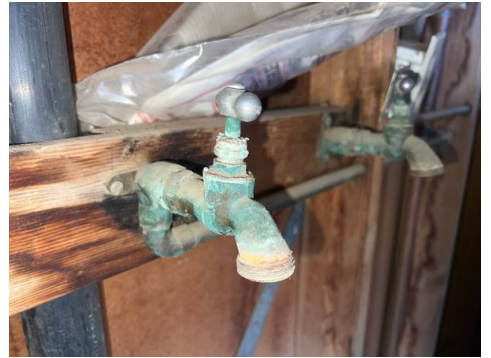
Corrosive build-up was observed at the washer supply valves. Corrosion can lead to water restriction, damage or leaking. These valves were not tested. I recommend having the valves replaced by a licensed plumber.

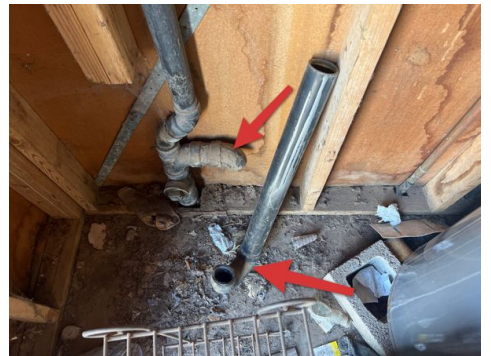
## 6.11.2 Washer Plumbing

The washer drain stand pipe is detached/damaged. I recommend consulting a licensed plumber for repair.

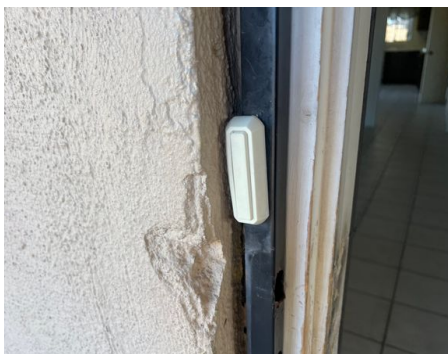
### Doorbell : Temporary doorbell

There is a temporary/plug-in doorbell installed. The system was tested and is functional.

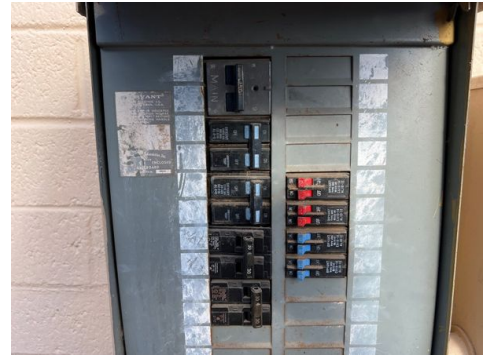
#### **CIRCUITS NOT LABELED**

Some of the circuits are not labeled at the service panel dead front cover. Each circuit should be clearly labeled. An electrician can be consulted for service.

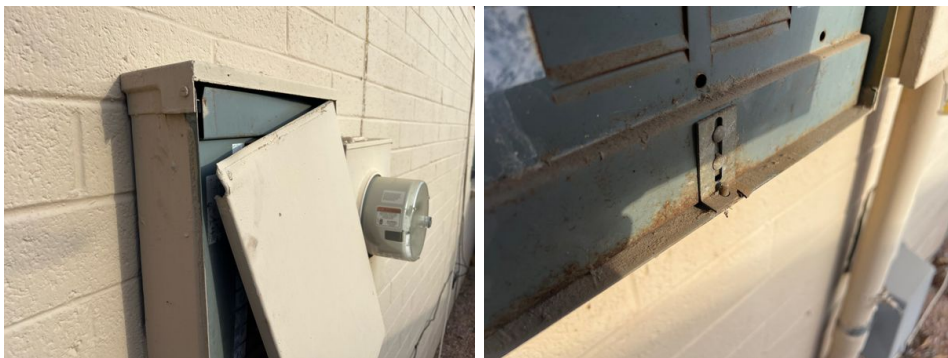
The main electric service panel cover/lid is damaged on the left side and loose. The locking tab is also damaged/partially missing. I recommend consulting a licensed electrician for repair.

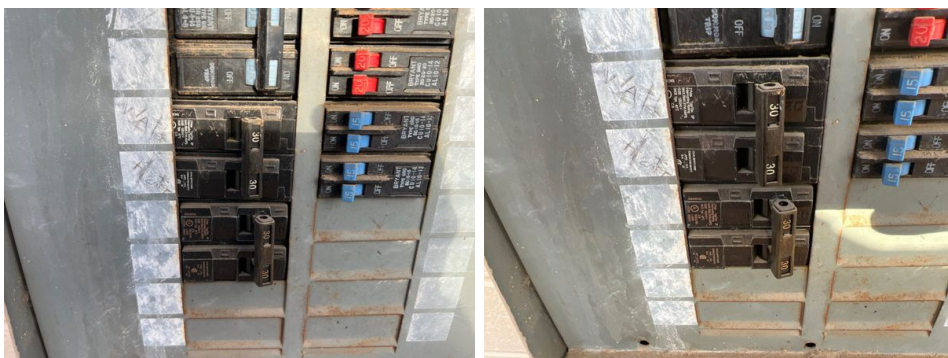
### 7.3.1 Branch Circuit Conductors & Over-Current Devices

At least two of the circuit breakers appears that they may not be compatible with the main electric service panel. One of these breakers is loose at the attachment to the bus bar. I recommend consulting a licensed electrician to review/service.

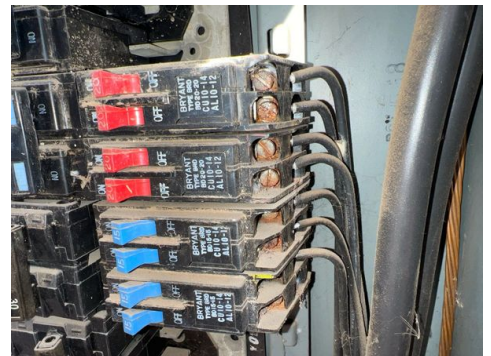
**RUST ON TERMINALS**

Rust was observed at circuit breaker terminals. Rust could lead to a loose/weak electrical connection which could result in excessive heat/resistance. I recommend consulting a licensed electrician to review/service.

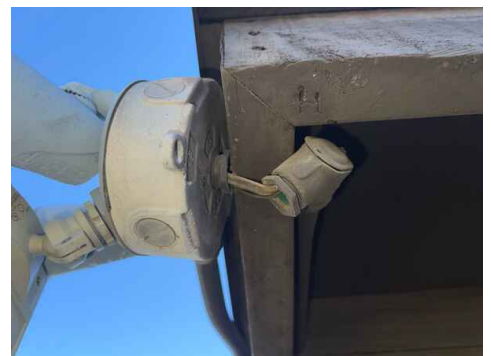
**LOOSE/DETACHED CONDUIT**

Detached electrical conduit with exposed conductors were observed at the rear floodlight. I recommend consulting a licensed electrician for repair.

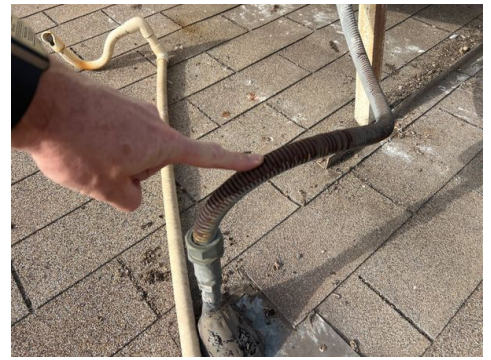
**DETERIORATED FLEXIBLE CONDUIT (ROOF)**

The flexible electrical conduit for the roof mounted HVAC equipment has deteriorated (the outdoor coating) due to prolonged UV exposure. Recommend replacement of the conduit by a licensed electrician.

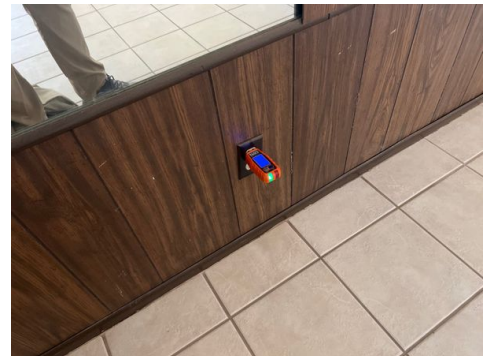
**LOOSE RECEPTACLE**

LIVING ROOM

Some of the receptacles are loose and easily moved within their enclosures or enclosures are loose in walls. I recommend securing where needed. An electrician can be consulted for service.

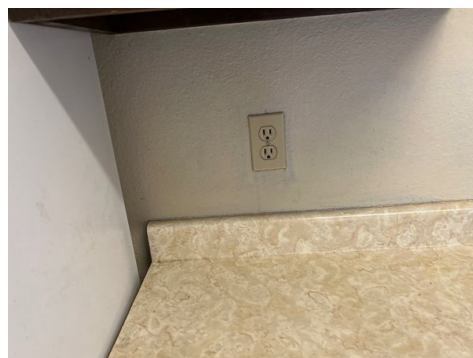
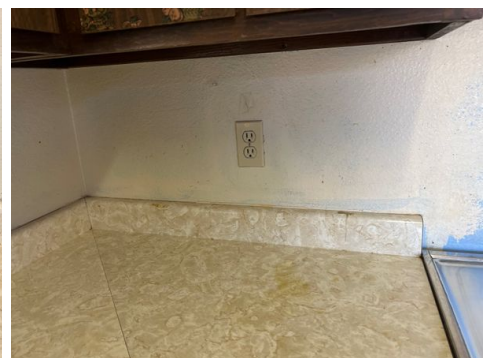
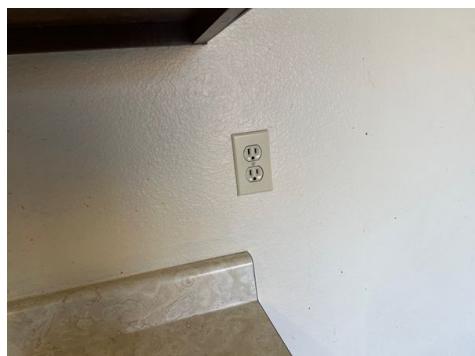
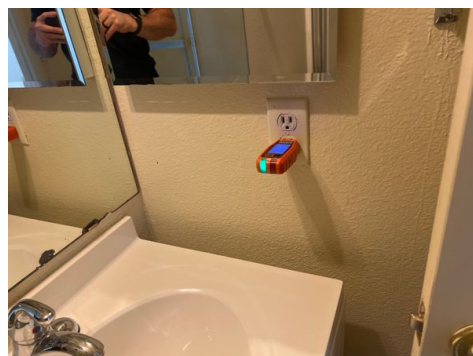
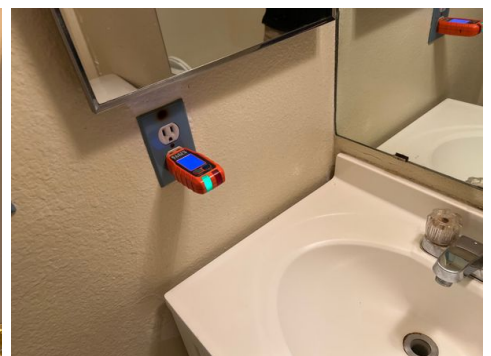
**MISSING GFCI PROTECTION PER CURRENT STANDARDS**

Ground fault circuit interrupters (GFCI) are not installed in some locations where they are now required. Although GFCI protection may not have been required in these locations when the home was built it is recommended as a safety precaution. I recommend consulting a licensed electrician to install GFCI protection where it is missing.

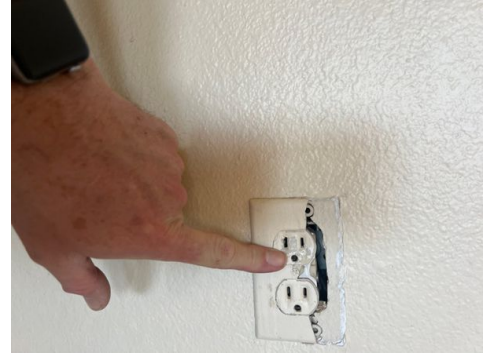
LIVING ROOM

The receptacle is obstructed. My tester was not able to be fully inserted. I recommend having the receptacle replaced by a qualified electrician.

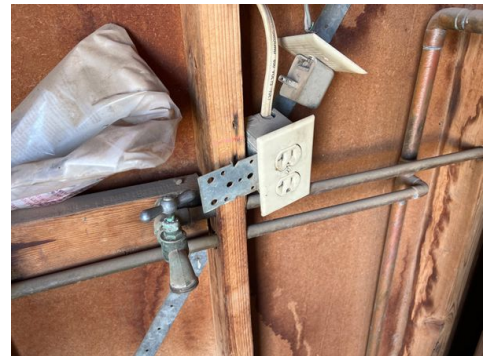
**LOOSE RECEPTACLE ENCLOSURE**

LAUNDRY ROOM/AREA

The receptacle enclosure is loose/not secured to or within the wall. I recommend consulting a qualified professional/electrician to secure the enclosure.

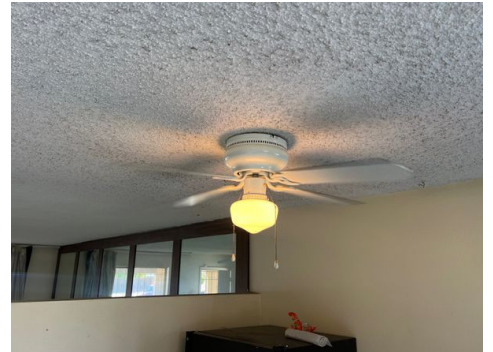
KITCHEN

The ceiling fan wobbles while in use. Hardware/fasteners could be loose. Balancing kits are also available if needed. A qualified handy person or electrician could be consulted for service if needed.

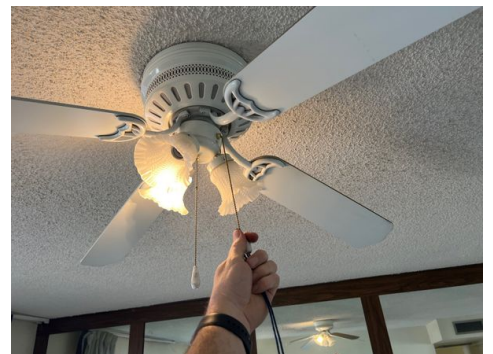
LIVING ROOM

The ceiling fan (motor) did not respond when tested. The fan was tested at wall switches and the pull chains. I recommend consulting a licensed electrician for service/repair.

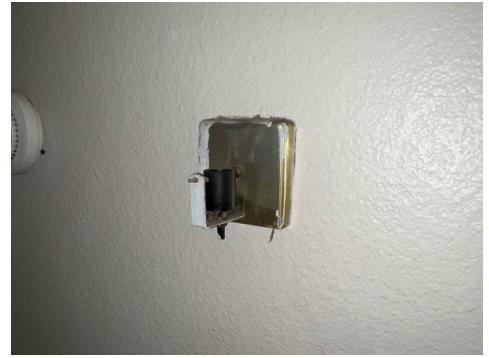
**MISSING LIGHT BULB**

HALL

Some of the light fixtures could not be tested as there are no bulbs installed. I recommend requesting bulbs be installed as needed so lights may be retested at final walk-through.

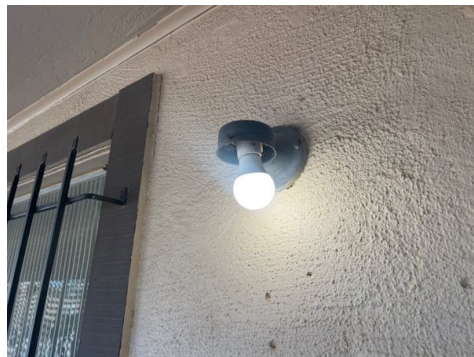
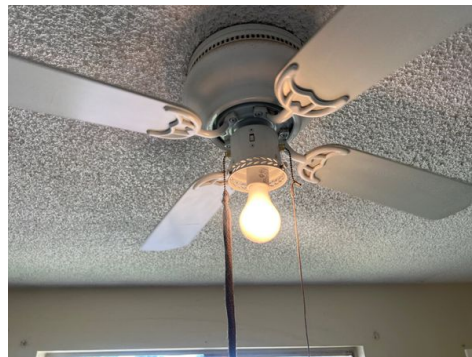
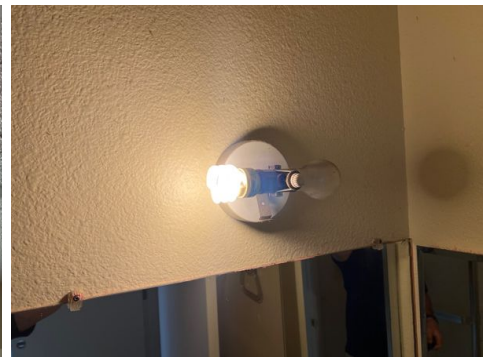
**MISSING LIGHT COVERS**

Some of the light fixtures are missing covers or glass domes.

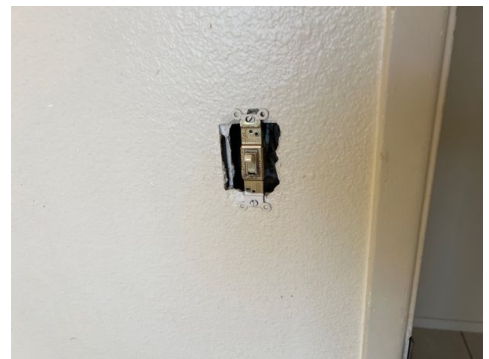
I recommend installing switch covers where missing so that terminals and conductors are not exposed.

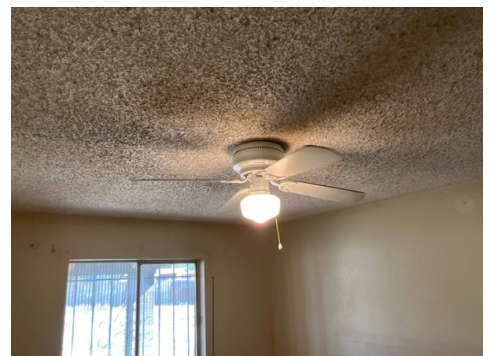
GUEST BEDROOM

The ceiling fans could be considered noisy while in use. A qualified electrician could be consulted for service if needed.

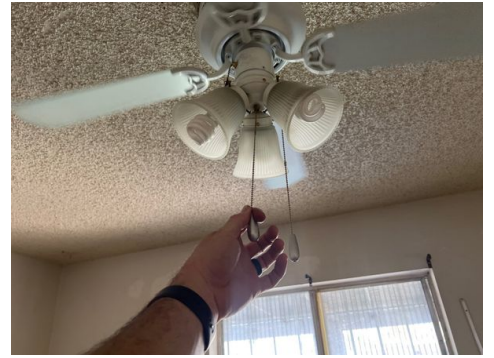
REAR GUEST BEDROOM

The chain for the ceiling fan is seized and physically not able to be pulled. I recommend consulting a qualified professional/electrician for repair.

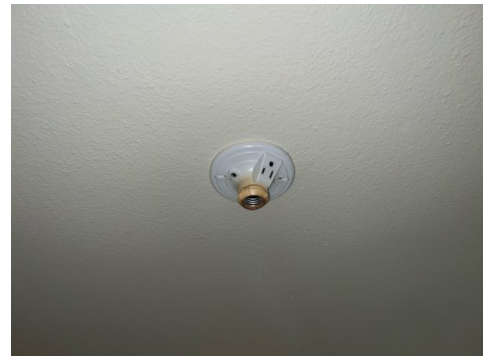
### **MISSING SOCKET LIGHT CHAIN**

PRIMARY BEDROOM CLOSET

The socket style light fixture is missing the chain. The light could not be tested. I recommend consulting a licensed electrician for repair or replacement.

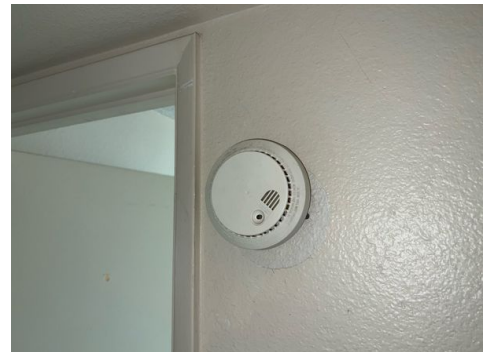
HALL

Some smoke detectors appear as though they could be older than approximately 10 years. It is generally recommended that smoke detectors be replaced at ten year intervals or less. I recommend replacement where necessary by a qualified professional/electrician.

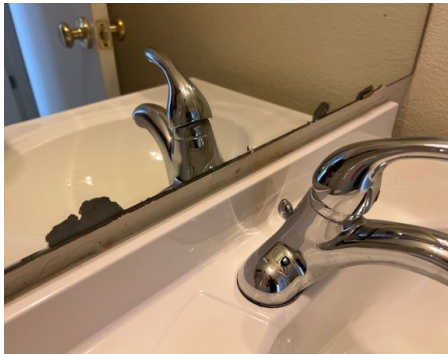
### Walls & Ceilings : Mirror de-silvering

Minor mirror de-silvering was observed. Mirrors would still be considered usable.

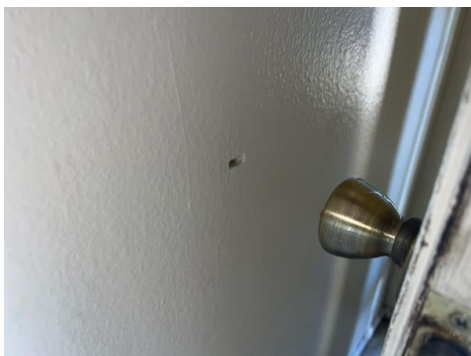
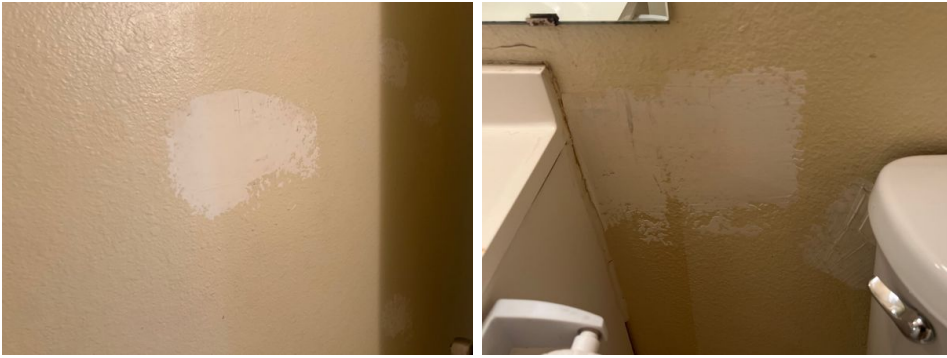
### COSMETIC CONDITIONS/REPAIRS

Cosmetic drywall conditions observed include small dents, common hardware holes as well as chipped or scraped paint. Drywall has been patched or repaired in some areas however, repairs might not be considered finished.

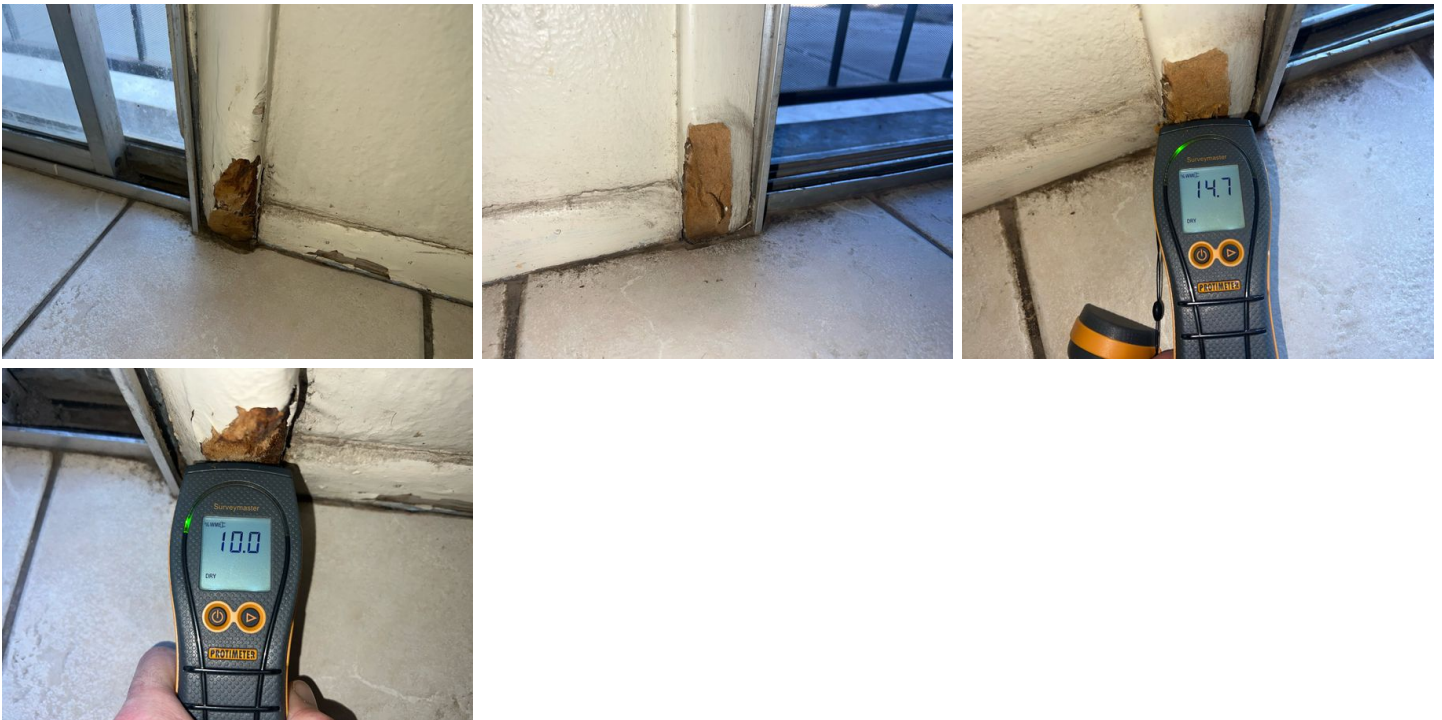
**CASING MOISTURE DAMAGE**

Interior casing for the kitchen sliding glass door is moisture damaged at the bottom. I recommend consulting a qualified professional for replacement. No elevated moisture was indicated at the time of the inspection.

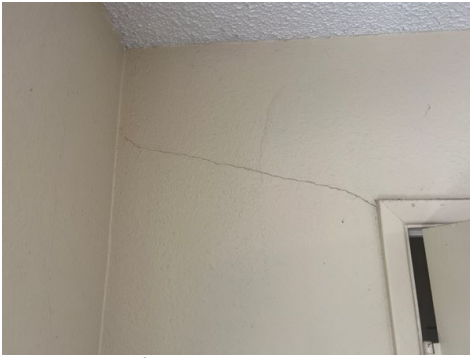
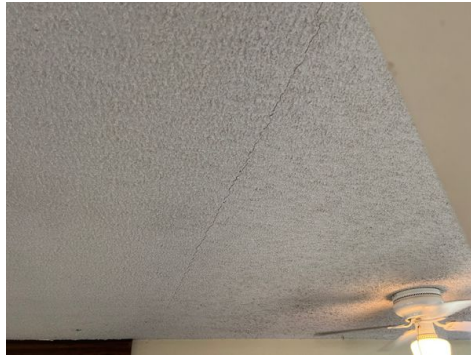
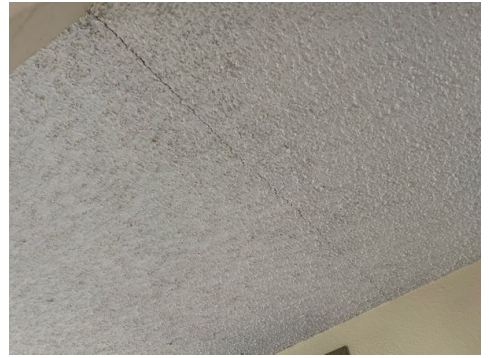
**CRACKED DRYWALL**

Interior drywall cracks were observed in some areas. Cracking appears as though it could be a result of (potentially significant) movement or settling, specifically at the corner of the guest primary bedroom closet. I recommend consulting a licensed contractor to further review.

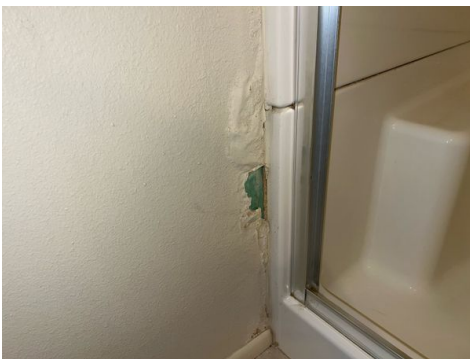
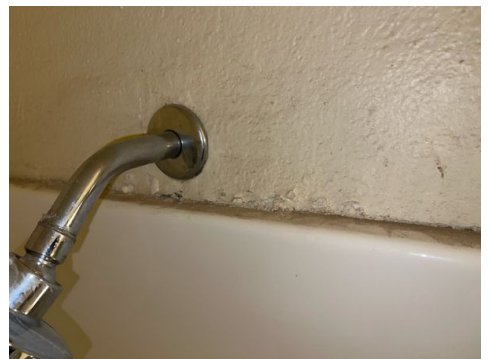
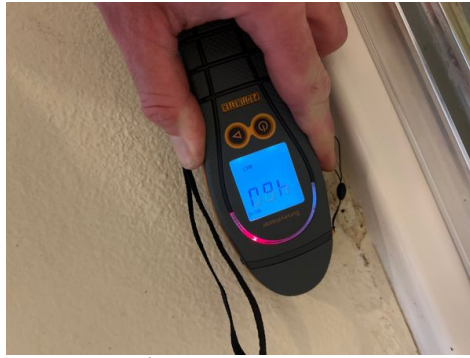
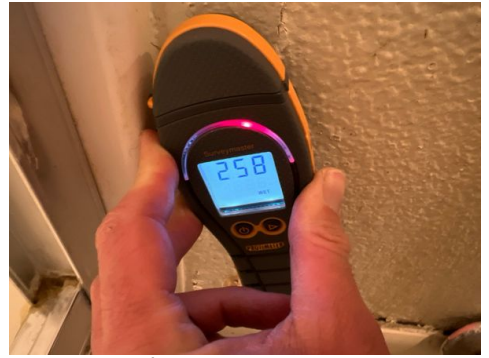
**MOISTURE DAMAGE NEAR SHOWER & TUB**

Moisture damage was observed at each side of the primary bathroom shower. Moisture appears as though it is originating from within the shower, potentially through openings between the shower floor and walls. Moisture damage was also observed below the showerhead. Moisture damage to a lesser degree was observed next to the guest bathroom tub. Elevated moisture was indicated next to the primary bathroom shower, but not next to the guest bathroom tub. I recommend consulting a licensed professional to review and repair.

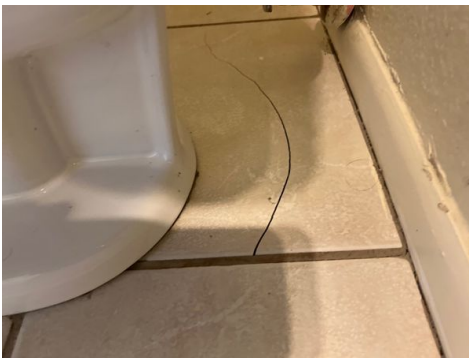
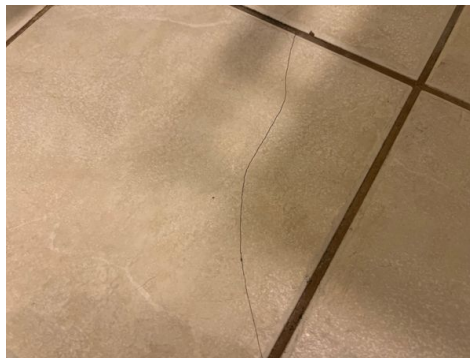
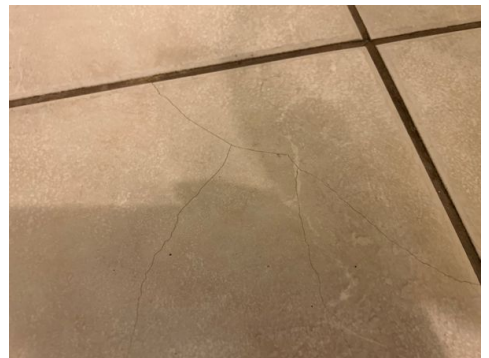
**CRACKED/MISSING TILE IN BATHROOMS**

Cracked/damaged and loose floor tile were observed near the primary bathroom shower and toilet. The condition could be a result of leaking nearby. Tile and baseboard has been removed next to the guest bathroom cabinet. There are also a few loose floor tile in this area as well. I. recommend consulting a licensed contractor to review/repair.

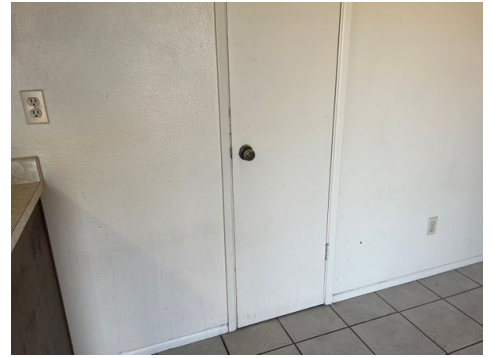
Pantry

Interior door(s) rub the door jamb when opening and closing. A door repair professional can be consulted for service/adjustment.

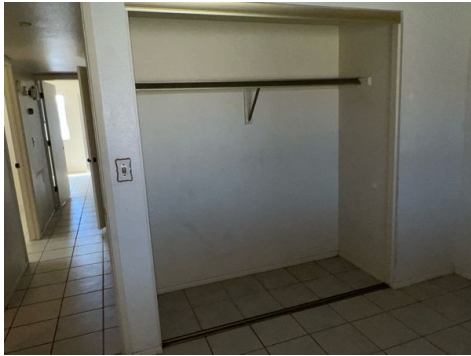
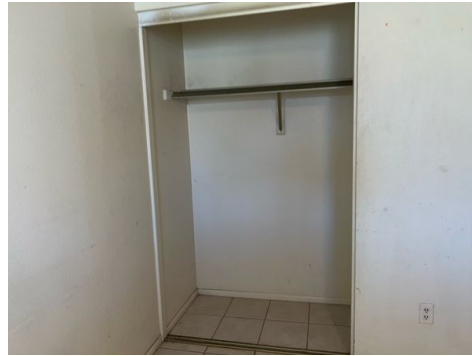
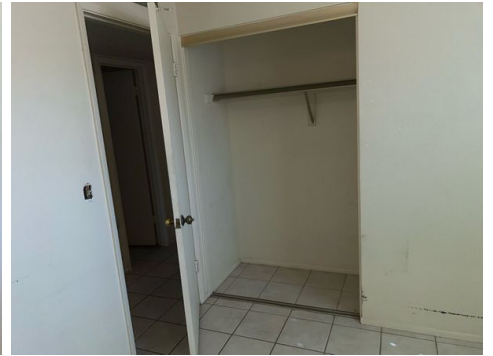
GUEST BEDROOM CLOSETS

Interior door(s) have been removed. I recommend inquiry with the seller regarding availability of the doors and/or consulting a qualified door installer if needed to replace.

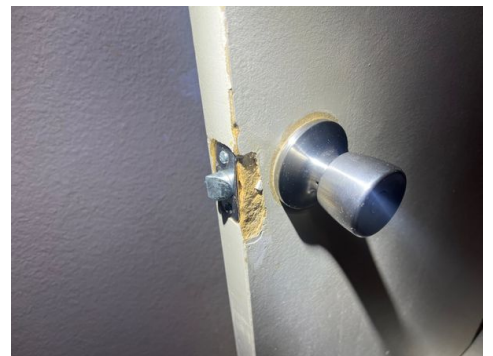
**DAMAGED INTERIOR DOOR**

Physical damage was observed at (some) interior doors. A door repair and installation professional can be consulted for service as needed.

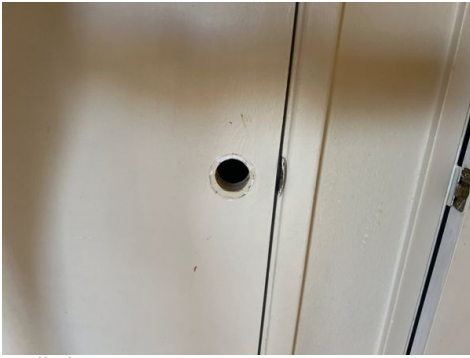
Hall closet

**MISSING LATCH/HANDLE**

Handle and latch hardware is missing at the interior door. A qualified door repair professional could be consulted to install these components if needed.

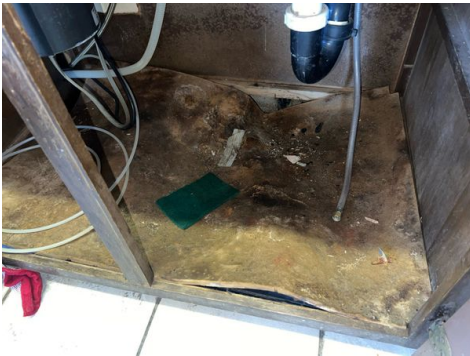
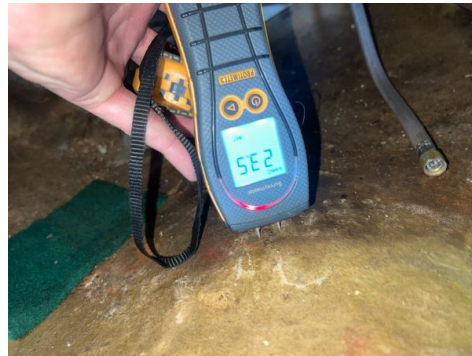
**WATER/MOISTURE DAMAGE**

Water/moisture damaged cabinet paneling was observed. Elevated moisture was indicated below the kitchen sink and bottom of guest bath cabinet. I recommend consulting a cabinet repair professional to replace damaged materials. Please note, similar moisture damage conditions could exist in non-visible areas.

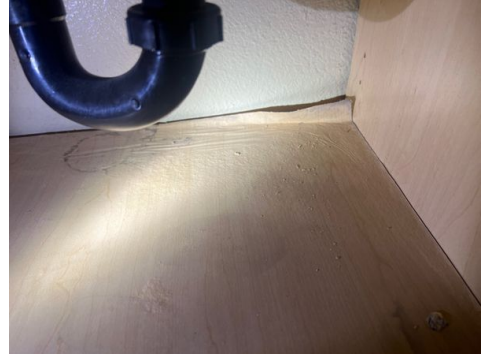
### **CABINET FLOOR SURFACE DAMAGE**

Surface damage and loose contact paper was observed at the cabinet floor below the guest bathroom sink. Material can be replaced as needed by a qualified cabinet repair professional.

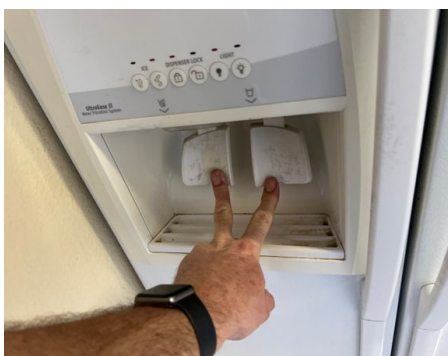
Refrigerator : No water supply

Please note that there is no/appears to be no water supply installed for the refrigerator.

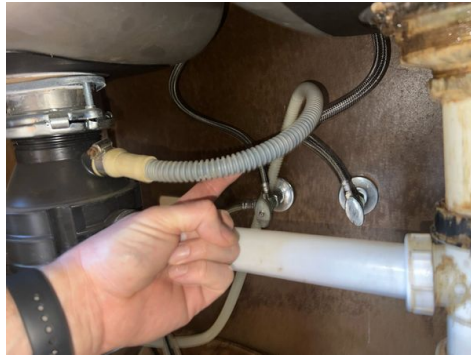
MISSING HIGH LOOP

The dishwasher drain is not secured in a manner that provides a high loop. A high loop will help to prevent waste water from draining from your sink to your dishwasher and will help keep water from settling in the hose after draining. I recommend securing the hose high under the sink between the dishwasher and sink drain or garbage disposal connection (as pictured).

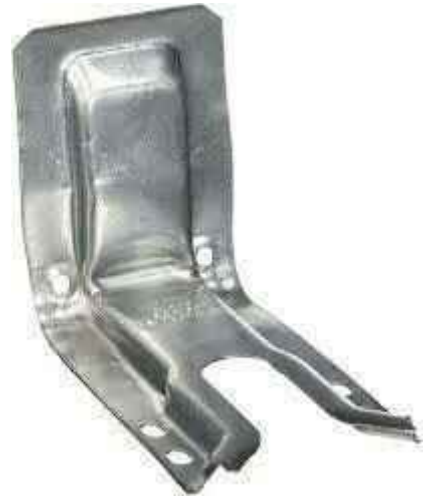
#### **MISSING ANTI-TIP DEVICE**

There is no anti-tip device installed to secure the oven to the floor. This is a potential safety concern. I recommend consulting a qualified professional to install anti-tip device.

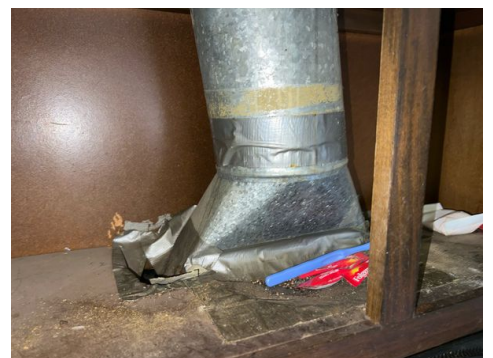
#### **DUCT TAPE**

Duct tape is applied to help seal the range hood vent. Heat tolerant foil tape is more appropriate. A qualified handy person could be consulted if needed for service/replacement.

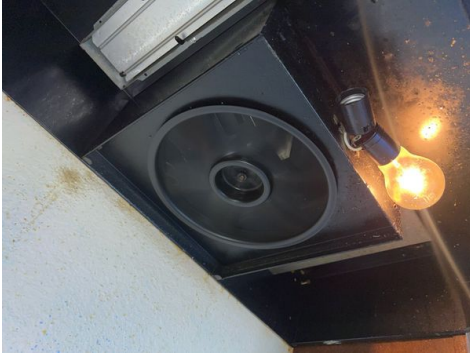
#### **MISSING FAN COVER**

The range hood fan cover is missing. Fan blades are exposed which could cause bodily injury. I recommend replacing the cover. An appliance repair professional can be consulted for service if needed.
